# Property Inspection Report

Property inspection completed by CIS Group powered by Navigator

Insured:	**** *	Survey Address:	41830 150th St
Survey ID:	31977860	Survey City:	*****
Policy Number:	*****	Survey State:	**
Agent Name:	Andrew Schmitz	Survey Zip:	*****
Agent Number:	13803AH	Primary Phone:	*** **_****
Agent Phone:	6514568834	Valuation ID:	A5F5-GX79
Agent Email:	<a href="mailto:aschmitz@farmersagent.com">aschmitz@farmersagent.com</a>	Policy Inception Date:	07/26/2021
Replacement Cost Code:	HV	Inspection Type Out:	Exterior
Reclassified PPC:	8B		
ADHOCProjDesc:			
Transaction Type:	New Business on New Household		
Fireline Score:

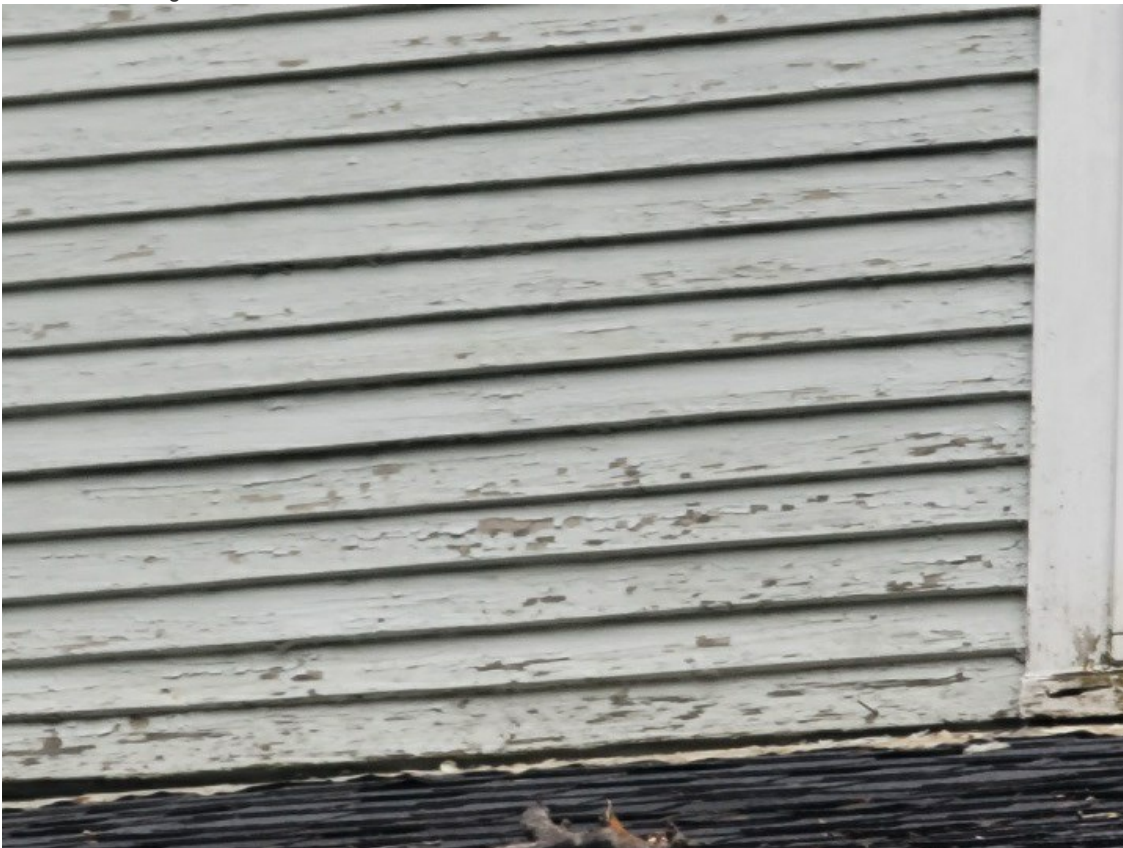
4Exterior Wall Hazard

Damaged: Damaged siding.

Paint Peeling / Unpainted: Paint is peeling and cracking.

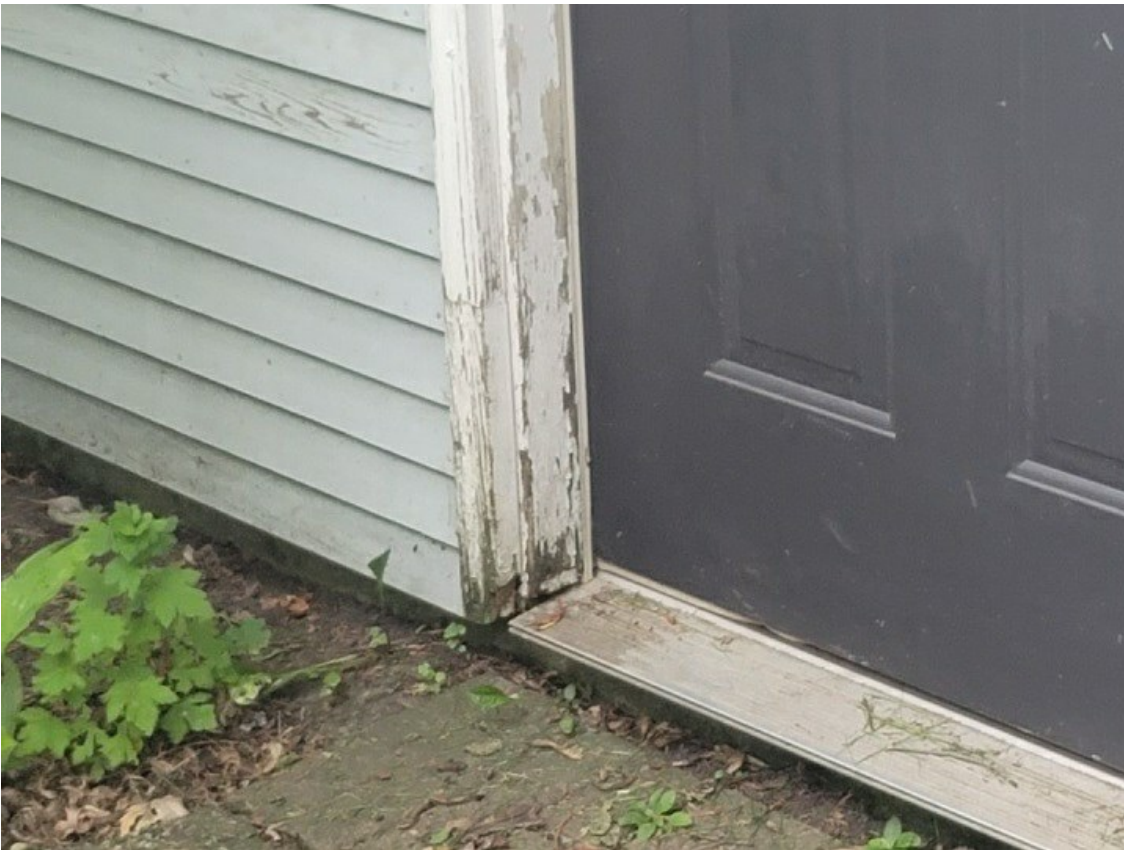
14 Detached Structure Hazard

Exterior Damage / Wear: Paint on door trim is peeling and cracking. Paint is peeling and cracking on siding.

Other (See Comments): Vines observed growing on detached structure.

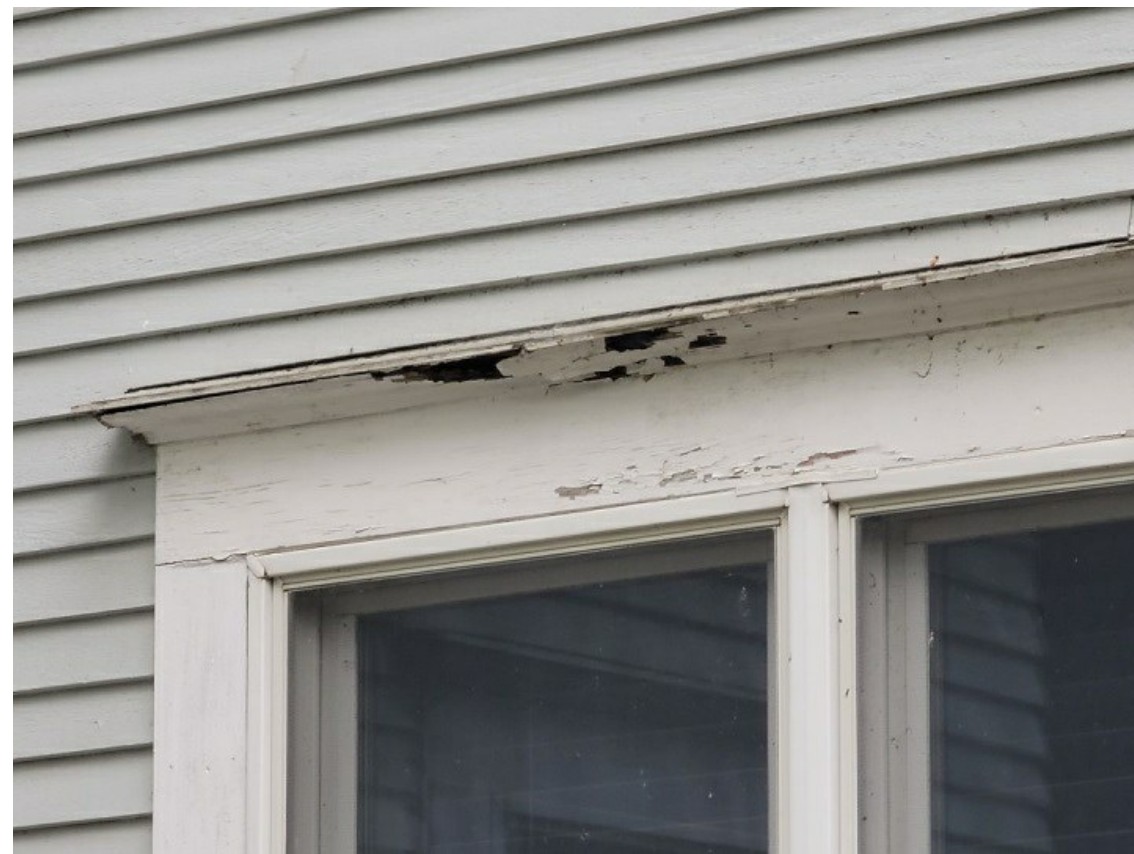
17Window Hazard

Paint Peeling / Unpainted: Paint on window pane is cracking and peeling.

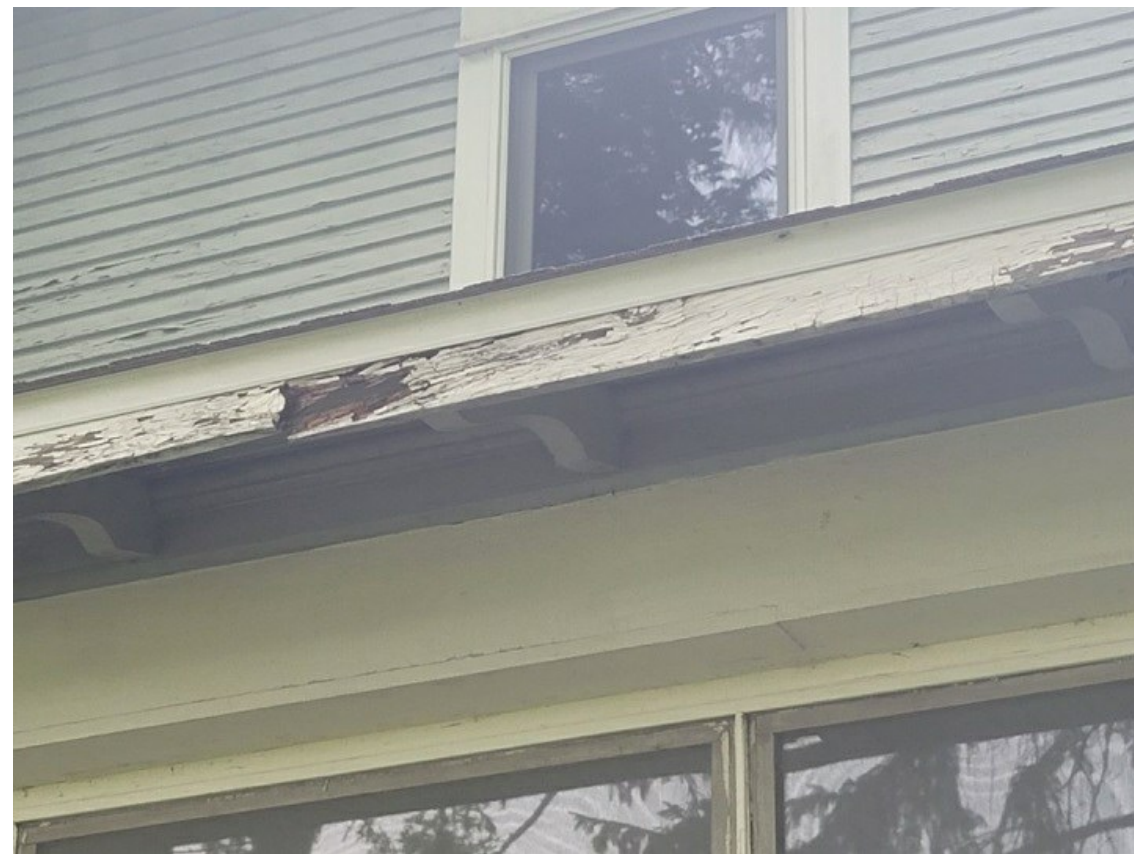
23Soffit, Fascia, Eaves & Overhangs Hazard

Paint Peeling / Unpainted: Paint is peeling and cracking on fascia.
