Property Inspection Report

Property inspection completed by CIS Group powered by Navigator

Insured:	ADRIENNE MEIER	Survey Address:	317 NICOLLET AVE
Survey ID:	31641534	Survey City:	NORTH MANKATO
Policy Number:	335119015	Survey State:	MN
Agent Name:	ANDREW SCHMITZ	Survey Zip:	56003
Agent Number:	13803AH		
Agent Phone:	6514568834	Primary Phone:	5078223770
Agent Email:	aschmitz@farmersagent.com		
Replacement Cost Code:	HV	Valuation ID:	A4Y6-NV65
Reclassified PPC:		Policy Inception Date:	05/08/2021
ADHOCProjDesc:		Inspection Type Out:	Exterior
Transaction Type:	New Business on New Household		
Fireline Score:

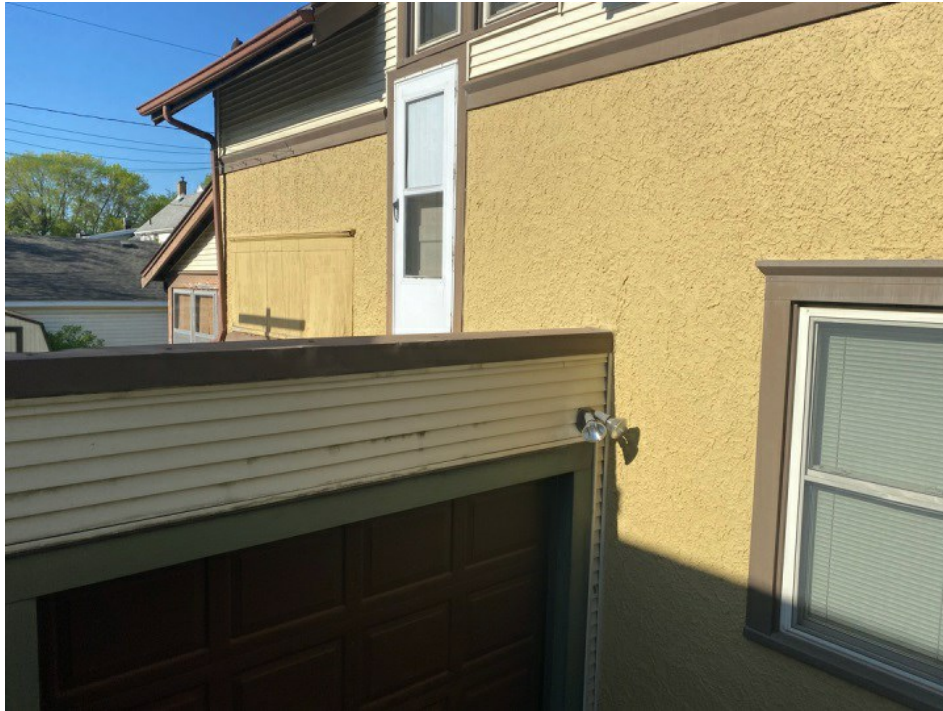
- Exterior Wall Hazard
 - Dry Rot: Dry rot observed on siding.
 - Paint Peeling / Unpainted: Paint showing extreme wear.
 - Other (See Comments): Patches evident.
- Porch / Patio / Deck / Stairs Hazard
 - Missing Railing: Missing railing on porch over 3ft.

Action Taken: Yes
 Action Type: Decline
 Notes: 335119015 Decline Legal w/ 7 day hold file: A 7 day hold file has been set to allow time for you to reach out to the insured as a courtesy, prior to any documentation being sent out to the insured. There are missing railings that need to be installed. Photos 9-10. The dwelling has peeling siding that needs to be painted/repared. The dwelling has ineligible siding material that needs to be replaced with an eligible siding material . Photos 24-29. Please note: that this risk may be eligible for coverage with Foremost or Kraft Lake. Estimated Cancellation Date: 7/19/2021

9 Porches, Patios, Decks & Stairs Hazard

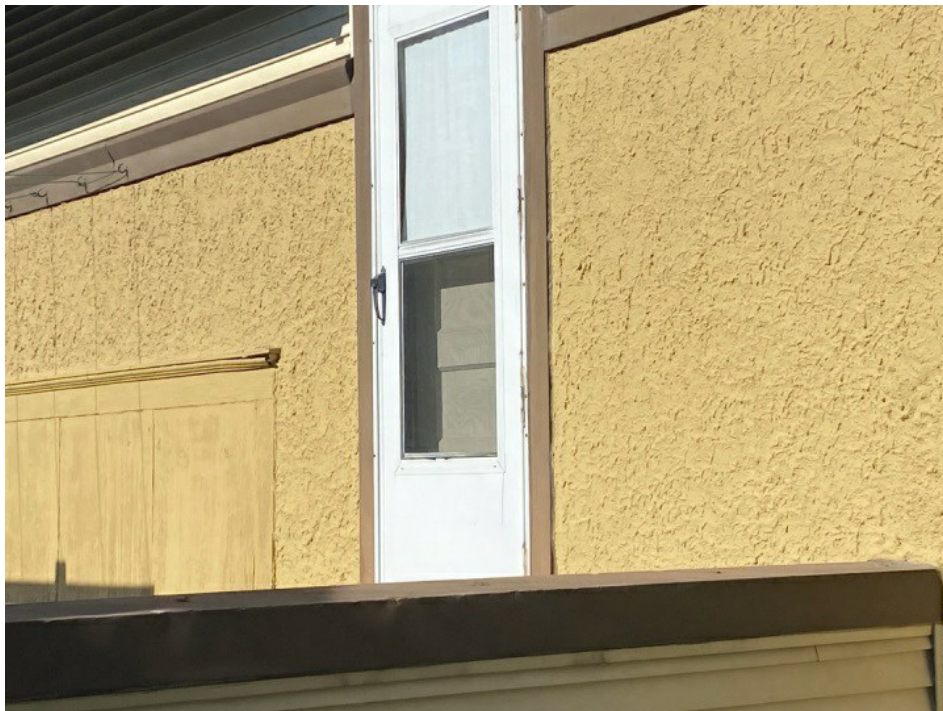
10 Porches, Patios, Decks & Stairs Hazard

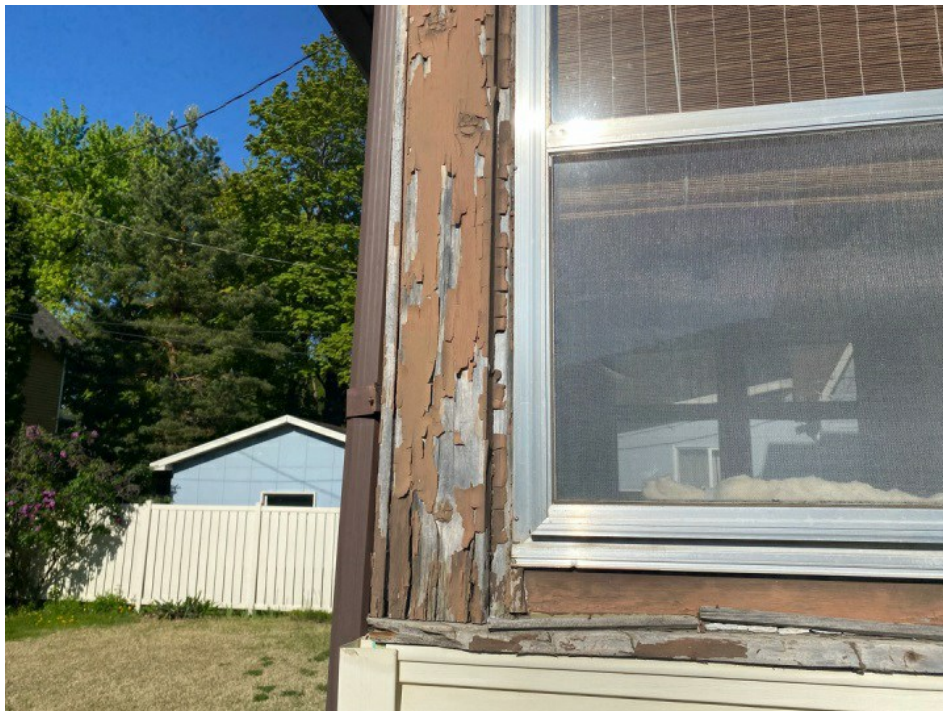
24 Exterior Wall Hazard

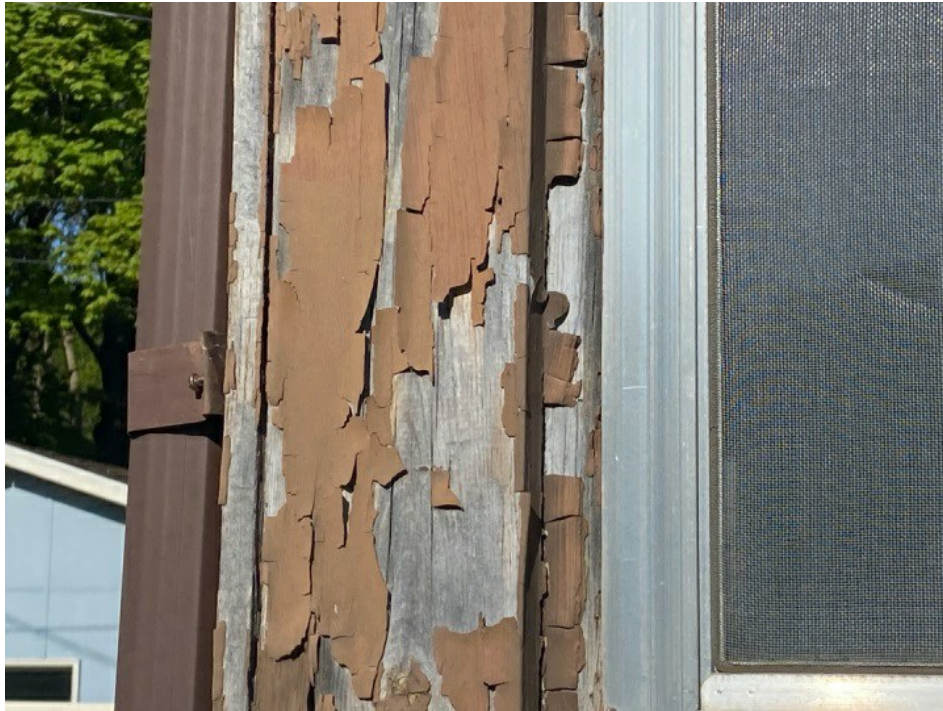
25 Exterior Wall Hazard

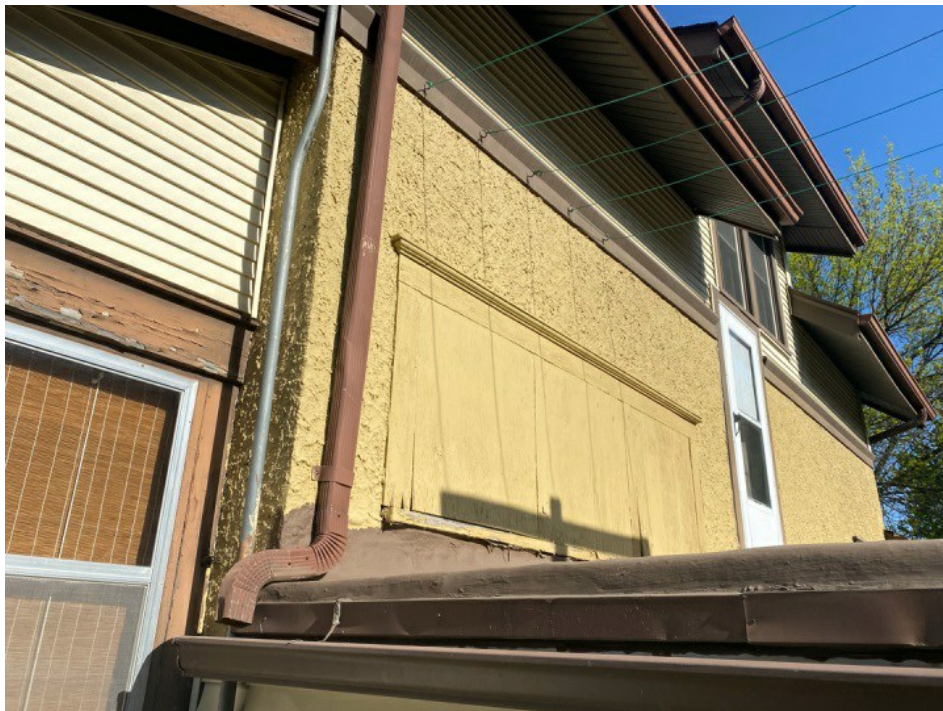
26 Exterior Wall Hazard

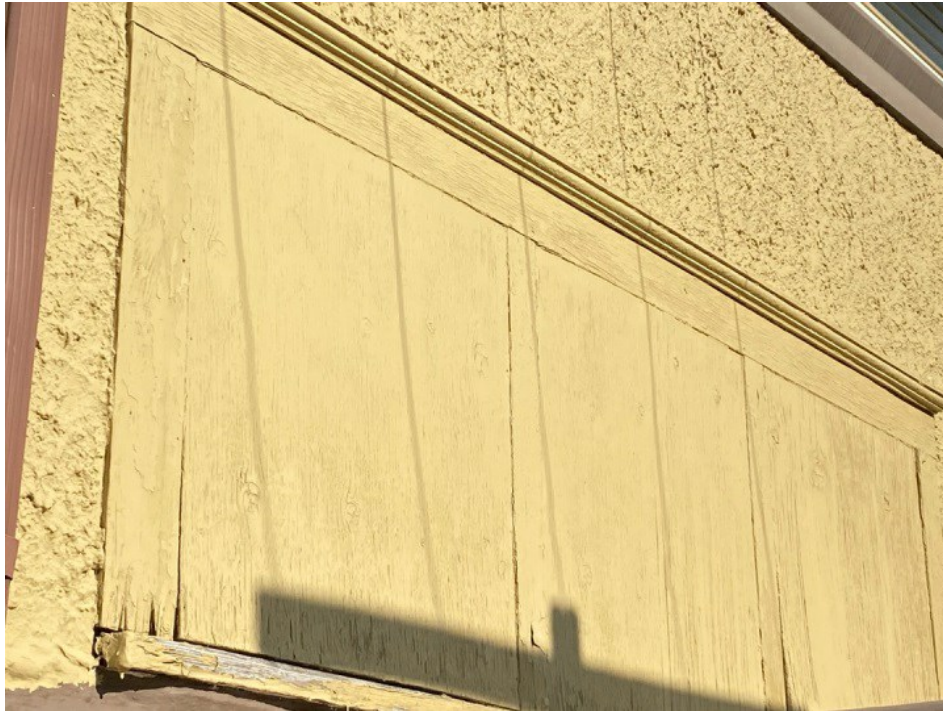
27 Exterior Wall Hazard

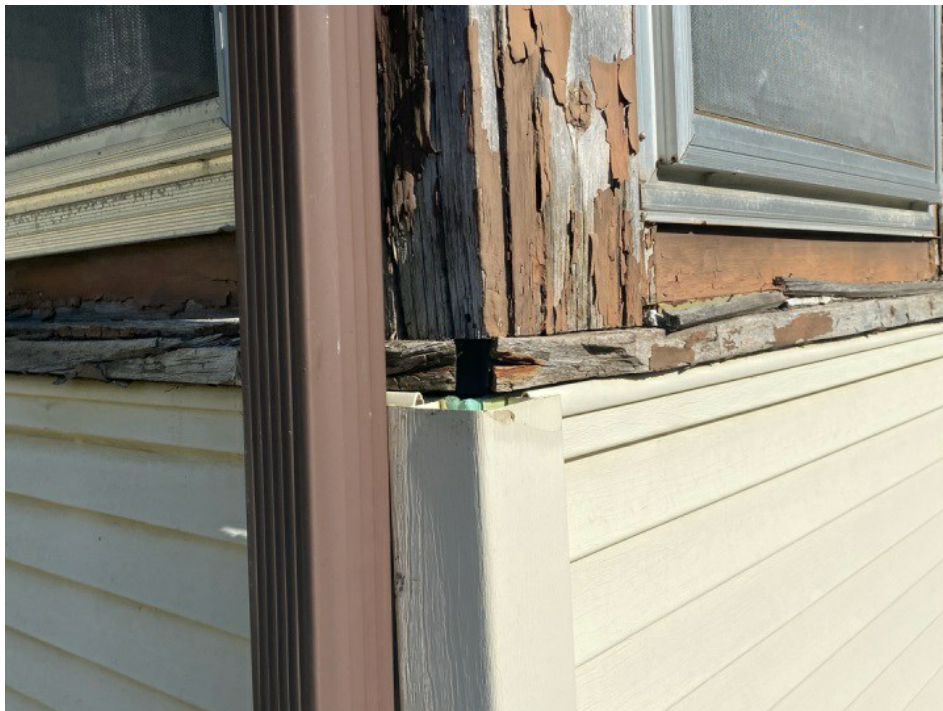
28 Exterior Wall Hazard

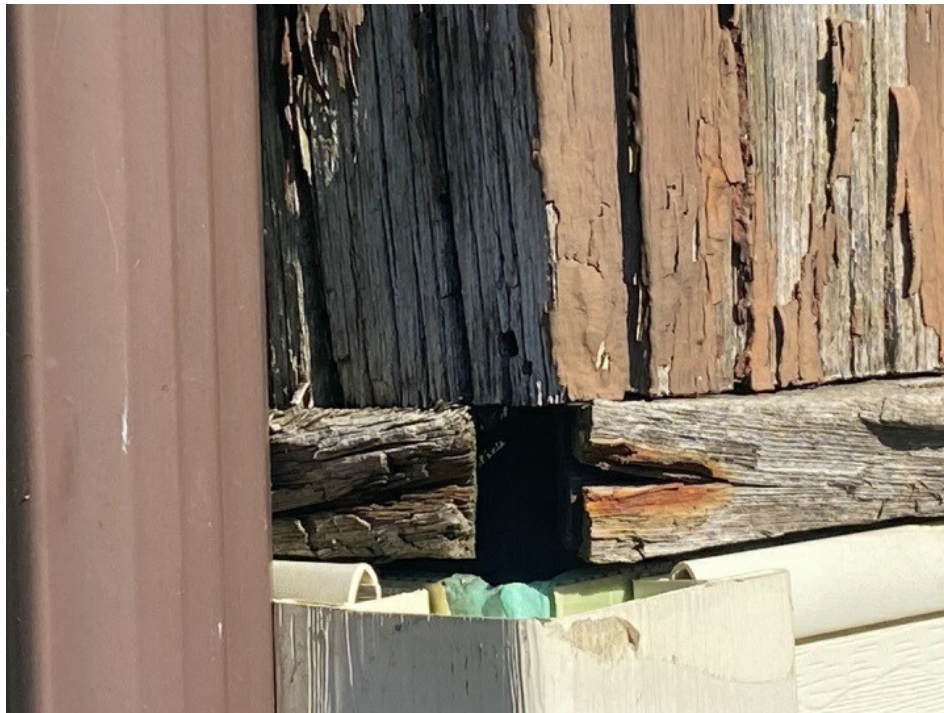
29 Exterior Wall Hazard
