Precision Real Estate Services

Karina Moen
14441 Scenic Heights Rd

Inspection Date 02/20/2023
Electric On Yes
Gas/Oil On Yes
Water On Yes
Temperature 30
Weather Cloudy Soil Conditions Frozen-Snow Covered
Space Below Grade Basement
Building Type Attached Twin Home Garage Attached
Water Source City How Verified Visual Inspection
Sewage Disposal City How Verified Visual Inspection

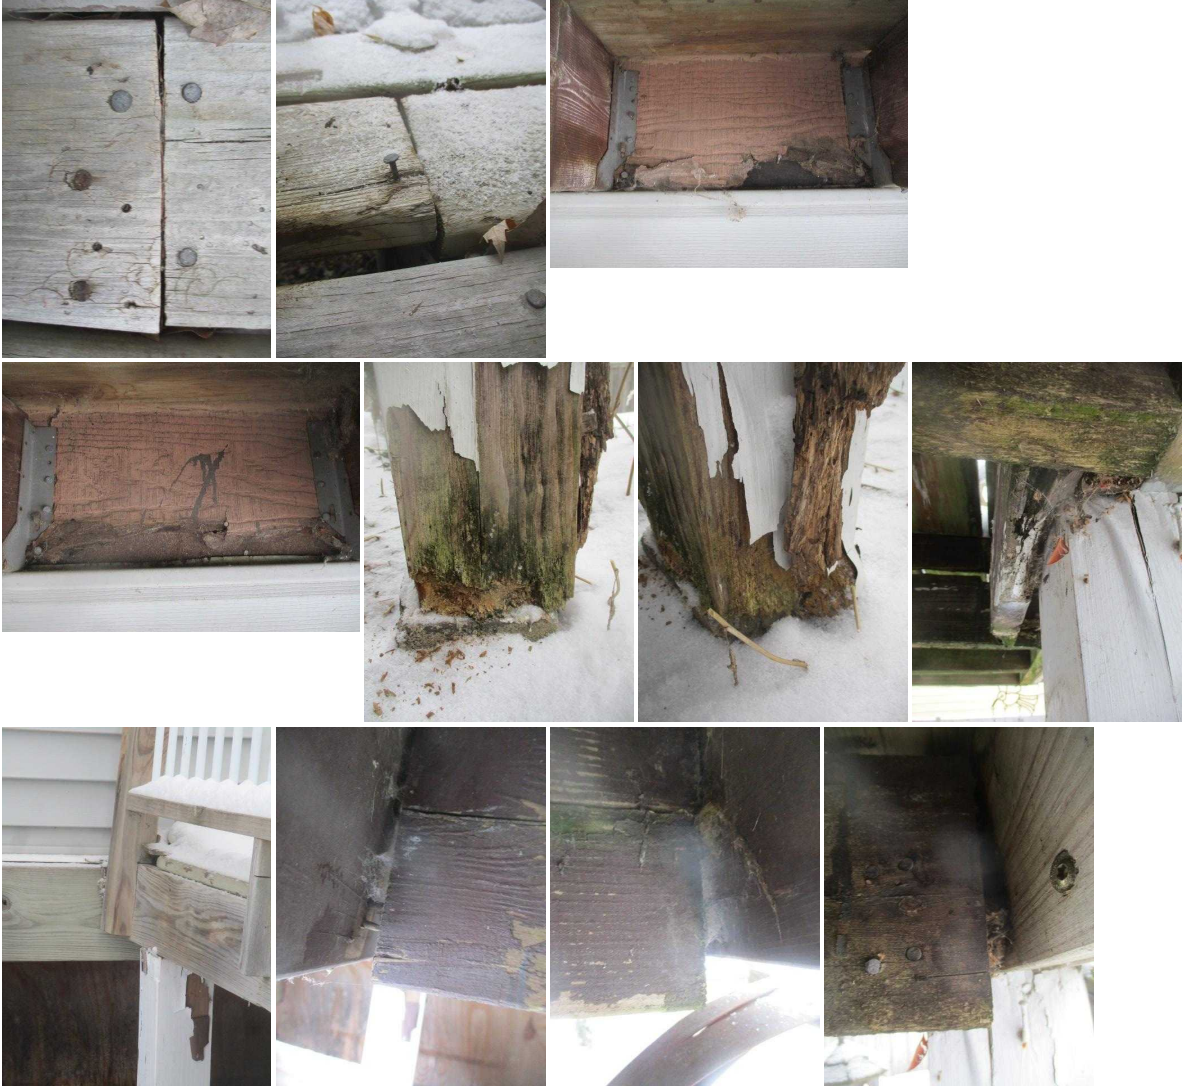
Acceptable Driveway: Asphalt? (100% Snow and Ice Covered)
Acceptable Walks: Concrete
Defective Deck: Wood - I recommend consulting with a licensed contractor for repairs at the deck ledger boards, 1 rotted posts, and several loose floor joists with exposed nails. The deck floor boards were secured via nails. Nails should be replaced with decking screws as needed where heads are exposed.

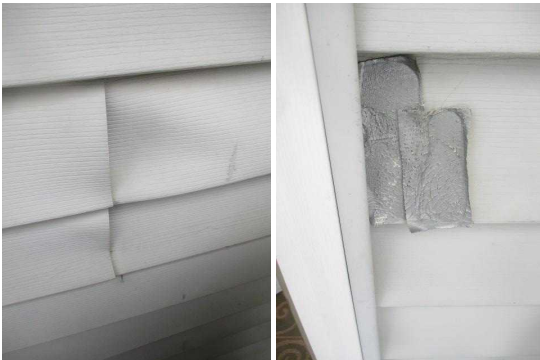
Acceptable Type: Vinyl Siding - Minor vinyl siding warp on the rear side of home at deck. It appears a hot grill was placed too close to the siding.

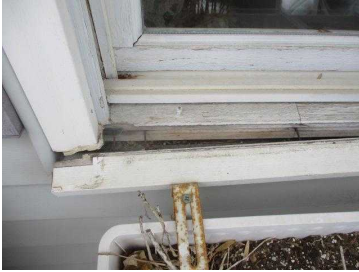
Defective Windows: Sliders - The deck window trim is damaged from the naging flower pot. Remove the flow pot and repair the frame.

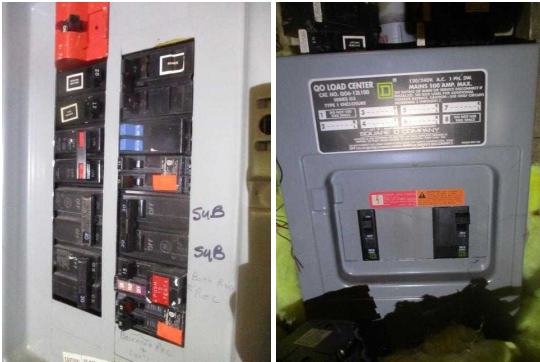
Marginal Manufacturer: Murray - The ledger for the main and sub electric panels are incomplete.

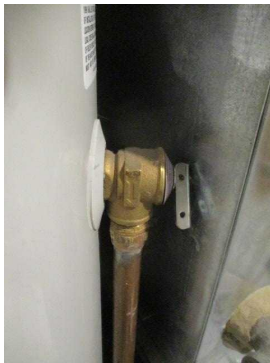
Acceptable Flue Pipe: Aluminum
Defective TPRV and Drain Tube: Copper Drain Tube - The TPRV valve is obstructed by the furnace supply air vent. This is considered a safety concern. If the water heater "overheats" the TPRV valve opens and releases the hot water. If obstructed, the valve won't open and water heater could burst.

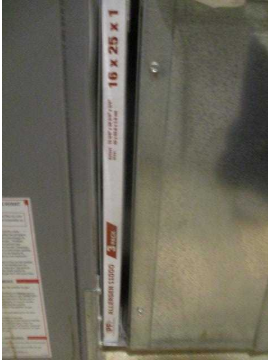
Marginal Blower Fan/Filter: Direct drive with disposable filter - The filter size is 16x25x1". Remember to replace according to manufactures recommendations.
The opening or slot for the furnace filter should be sealed to help reduce air flow loss through the return vent.

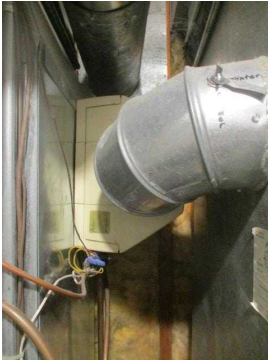
Acceptable Distribution: Metal Ducts
Acceptable Draft Control: Automatic
Acceptable Flue Pipe: Aluminum
Defective Humidifier: April-Aire - Access to the humidifier filter was restricted by the furnace return vent. I'm not sure how this was even installed!!! Do not use humidifier unless there's access to the filter.

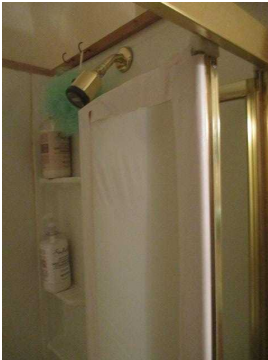
Marginal Shower/Surround: Tiled

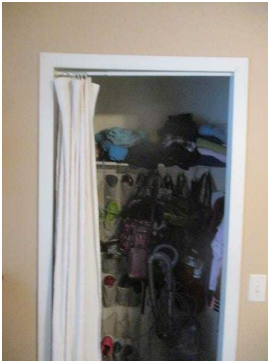
Marginal	Closet: Adequate - The closet door was removed in the upper front right (Master) bedroom. Is this still available for re-installation if desired? Inquire with owner.
----------	---

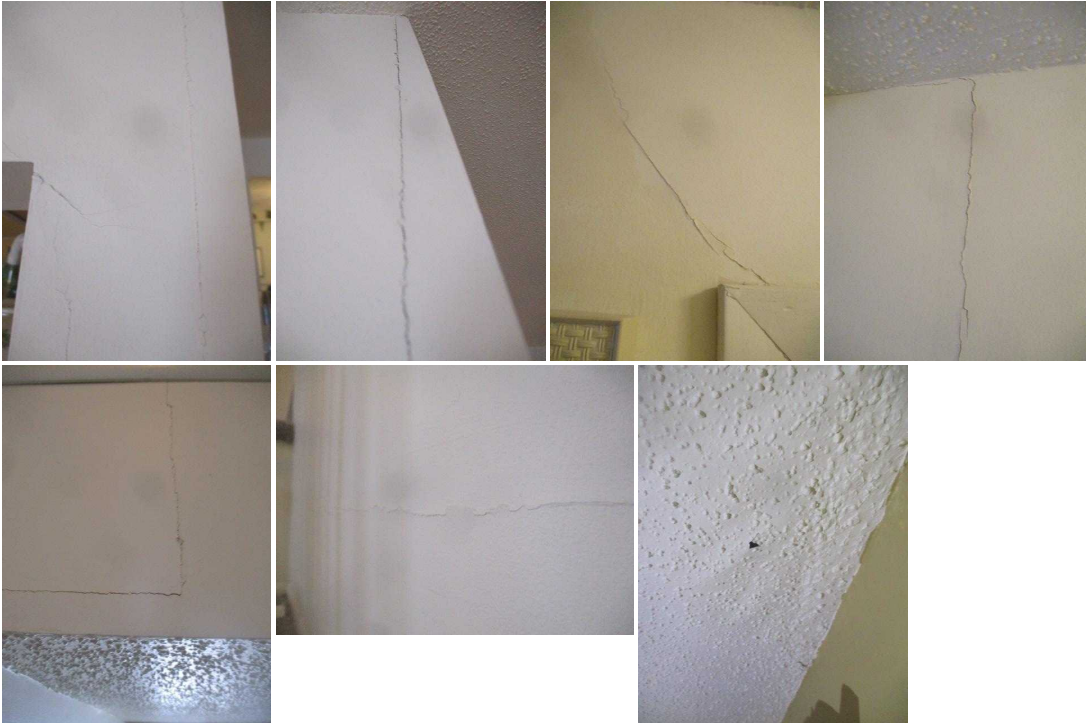
Lower Family Room, Main Floor Living Room, Loft Area Living Space
Acceptable Ceiling/Walls: Finished/Painted - Prior water damage suspected above the entry floor window. I suspect the damage occurred before the window was replaced.

Minor settling wall cracks were noted above the window in the main floor hallway, wall below loft, upper stairwell and hallway.

Sheet rock tape lines were noted in the basement stairwell. No repair is needed.

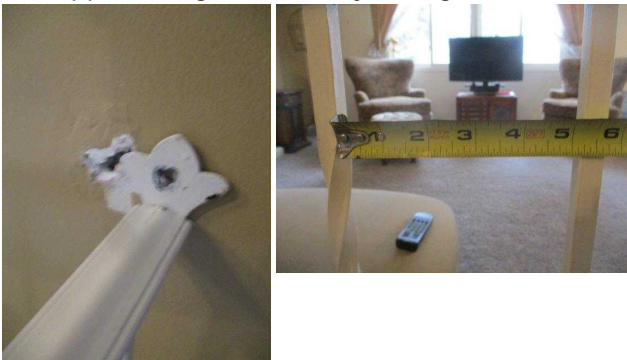
Marginal Stairs: Carpeted - The stairwell, upper Living room, and loft railing balusters are over 4" in width. This presents a safety issue for infants or young children which could fall through the gaps. The upper Living room safety railing is loose. It's not affixed to the wall.

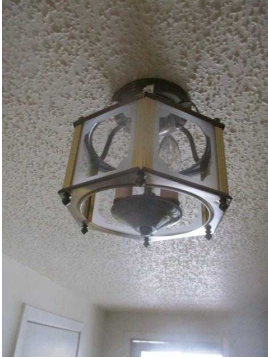
Defective Electrical: 110 VAC - The dimmer light switch in the Living room did not work when tested. I suspect this switch powered the lower position at the outlet on opposite wall.
The entry hallway light fixture did not work when tested. Replace bulbs and re-test.

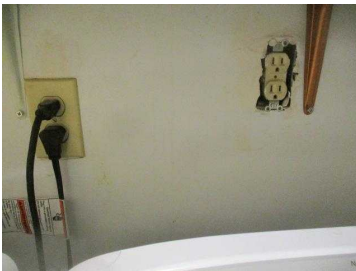
Marginal Electrical: 110 VAC - 2 GFCI protected outlets are recommend behind the clothes washer and dryer.
One outlet cover will also be needed.

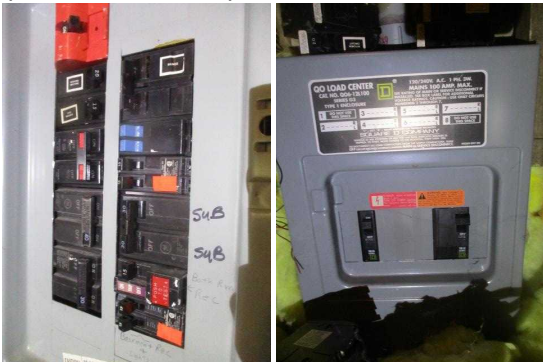
2. Smoke Detectors: 1 Battery Operated
3. Basement Family Room (Bedroom) Electric Panel Manufacturer: Murray - The ledger for the main and sub electric panels are incomplete.

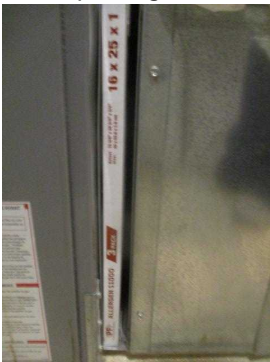
4. Mechanical Room Heating System Blower Fan/Filter: Direct drive with disposable filter - The filter size is 16x25x1". Remember to replace according to manufactures recommendations. The opening or slot for the furnace filter should be sealed to help reduce air flow loss through the return vent.

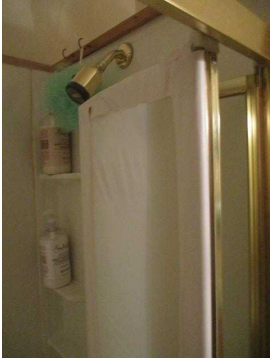
5. Both Bathrooms Bathroom Shower/Surround: Tiled

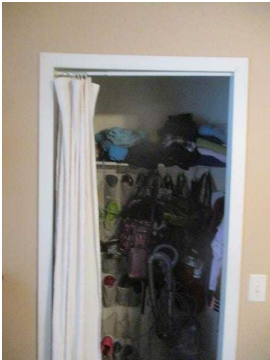
6. All Bedrooms Bedroom Closet: Adequate - The closet door was removed in the upper front right (Master) bedroom. Is this still available for re-installation if desired? Inquire with owner.

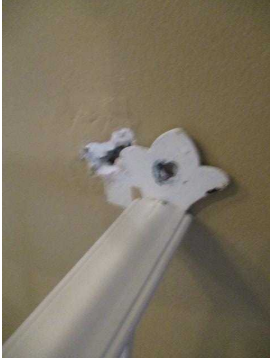
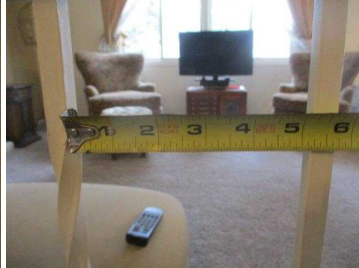
8. Lower Family Room, Main Floor Living Room, Loft Area Living Space Stairs: Carpeted - The stairwell, upper Living room, and loft railing balusters are over 4" in width. This presents a safety issue for infants or young children which could fall through the gaps.
The upper Living room safety railing is loose. It's not affixed to the wall.

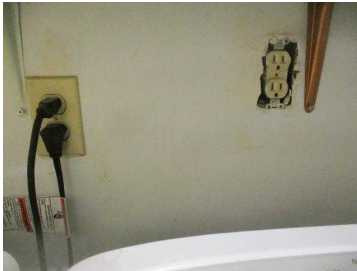
10. Mechanical Room Laundry Room/Area Electrical: 110 VAC - 2 GFCI protected outlets are recommend behind the clothes washer and dryer. One outlet cover will also be needed.

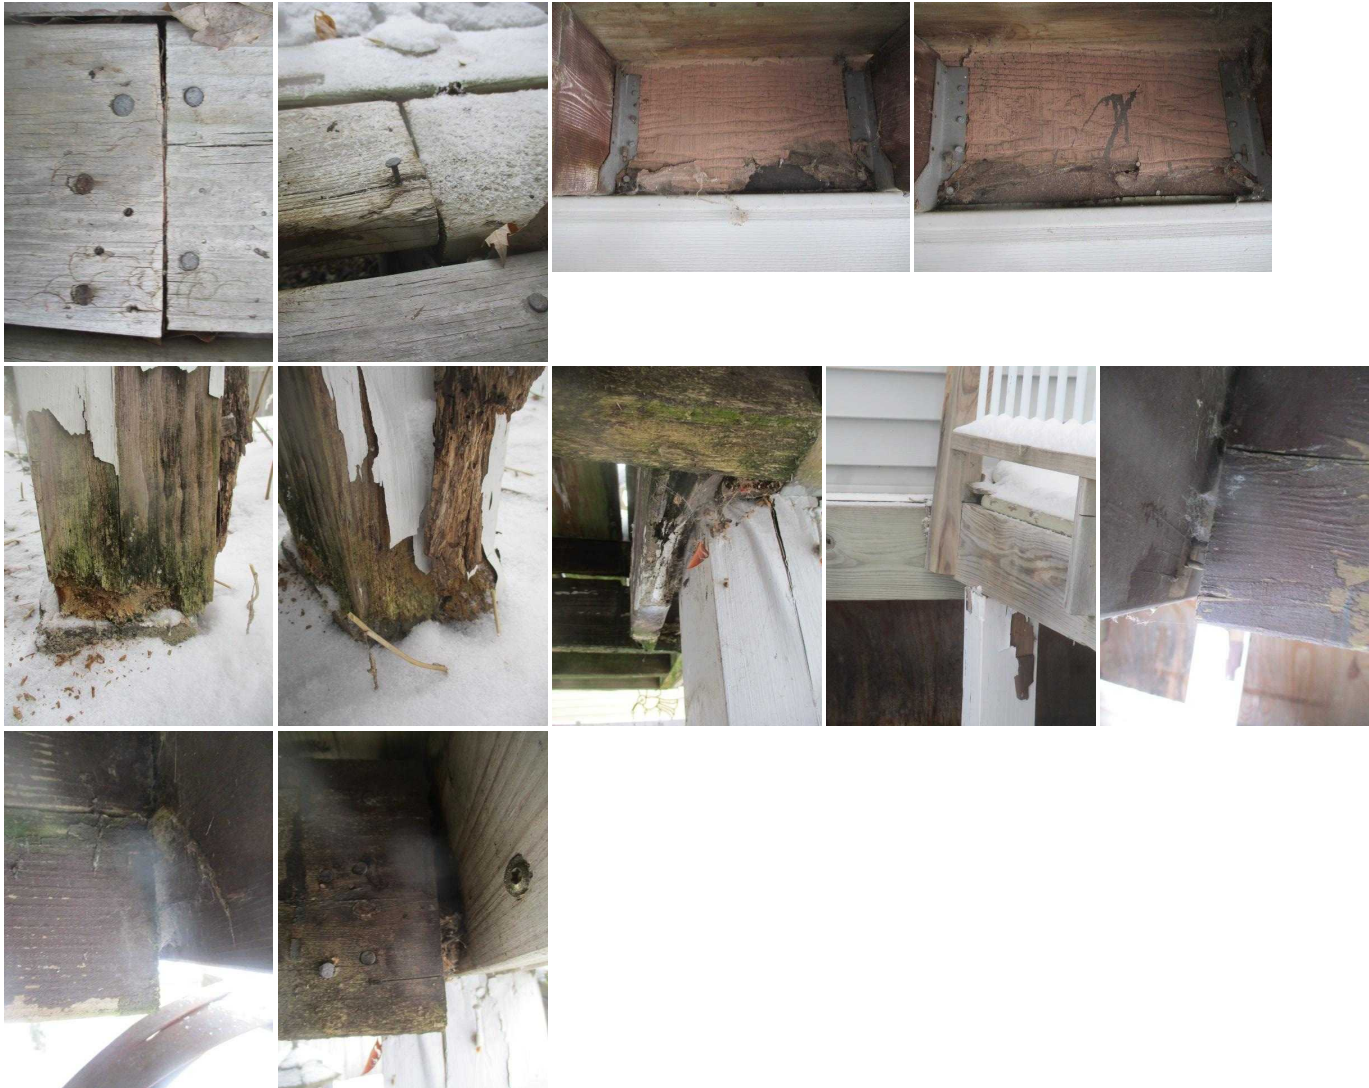
1. Deck: Wood - I recommend consulting with a licensed contractor for repairs at the deck ledger boards, 1 rotted posts, and several loose floor joists with exposed nails. The deck floor boards were secured via nails. Nails should be replaced with decking screws as needed where heads are exposed.

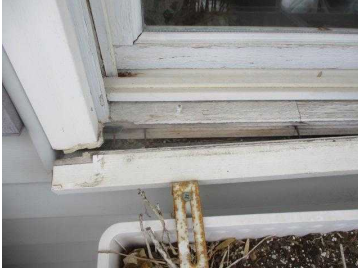
2. Windows: Sliders - The deck window trim is damaged from the naging flower pot. Remove the flow pot and repair the frame.

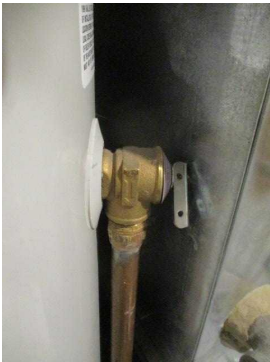
3. Mechanical Room Water Heater TPRV and Drain Tube: Copper Drain Tube - The TPRV valve is obstructed by the furnace supply air vent. This is considered a safety concern. If the water heater "overheats" the TPRV valve opens and releases the hot water. If obstructed, the valve won't open and water heater could burst.

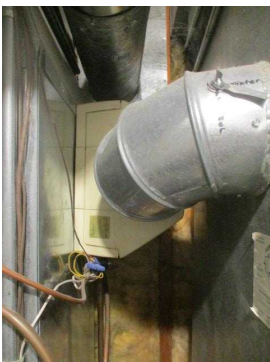
4. Mechanical Room Heating System Humidifier: April-Aire - Access to the humidifier filter was restricted by the furnace return vent. I'm not sure how this was even installed!!! Do not use humidifier unless there's access to the filter.

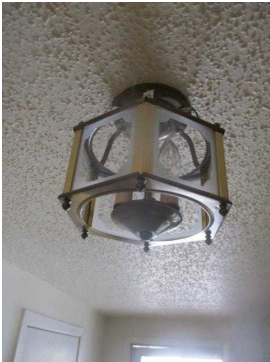
7. Lower Family Room, Main Floor Living Room, Loft Area Living Space Electrical: 110 VAC - The dimmer light switch in the Living room did not work when tested. I suspect this switch powered the lower position at the outlet on opposite wall.
The entry hallway light fixture did not work when tested. Replace bulbs and re-test.
