Customer Name	Sure (4.x)	Customer Number	1816
Address	2203 MEADS ST, ELIZABETH CTY, NC 27909	Year Built	--
Policyholder	GLORIA GORDON	Business Type	New
Control Number	18746172	Policy Number	NCRF78368600
Coordinates	36.3004383, - 76.2586058	Effective Date	06/20/2024
Inspection Date	07/30/2024	Date Completed	07/30/2024
TLA	2096	Inspected Total Living Area	1794
Coverage A In	\$377,000	Coverage A Out	\$364,920
Percent to Value	103%	At-home Completed	No

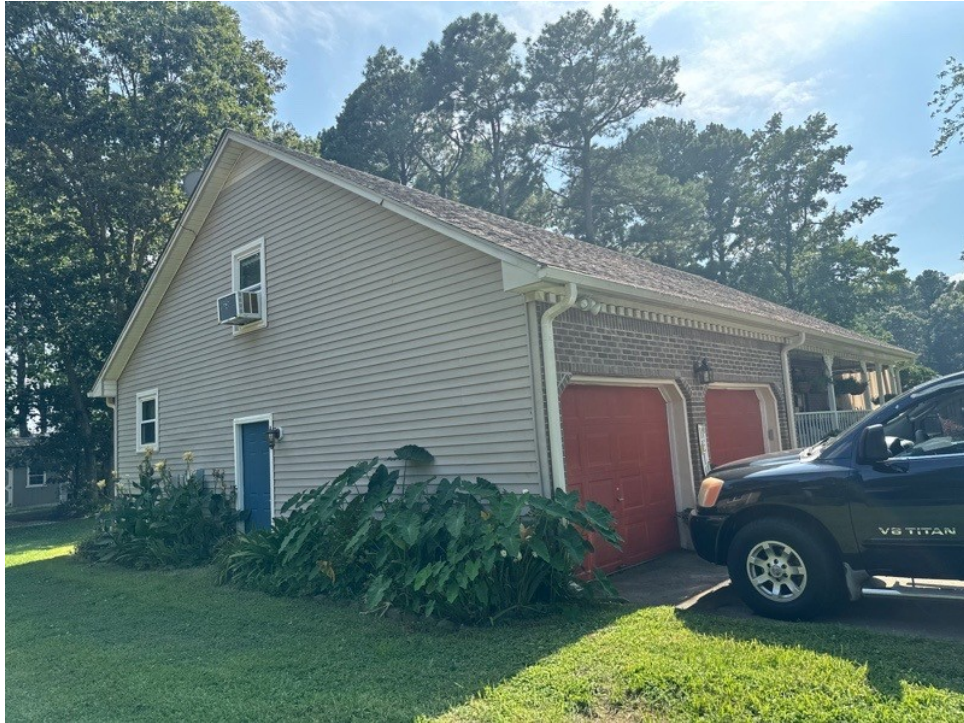
Left view, Dwelling, Gutters, Front, Downspout discharges onto walkway/driveway

Gutter concern identified:	Downspout discharges onto walkway/driveway	Location(s) of concern:	Front of dwelling
----------------------------	--	-------------------------	-------------------

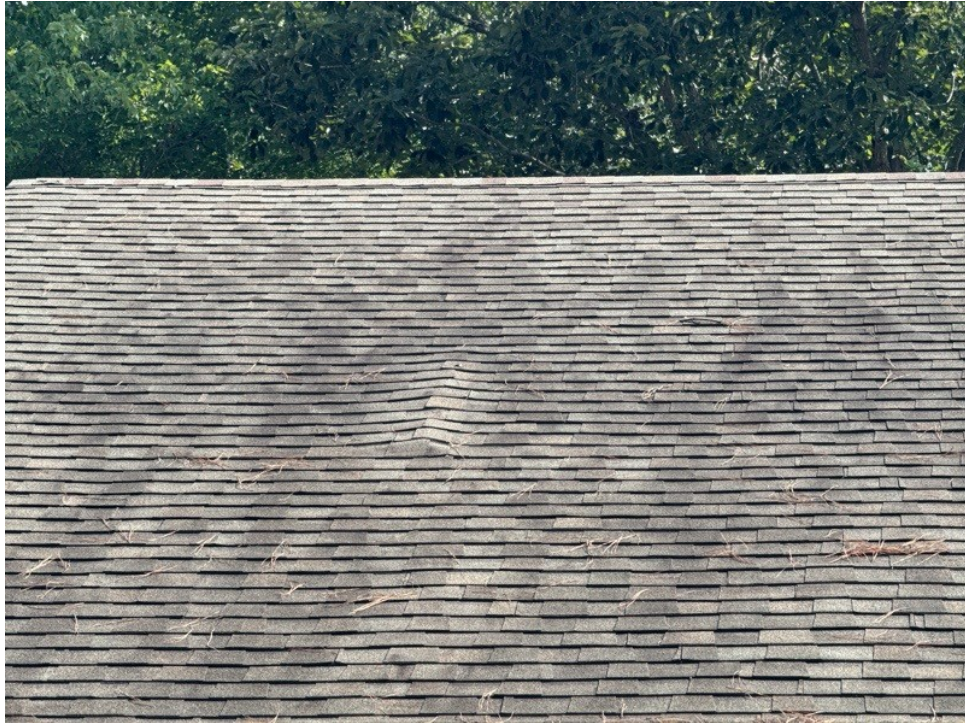
Roof verification, Left, Right, Dwelling, Roof, Front, Sagging/Bowed

Roof concern identified:	Sagging/Bowed roof	Location(s) of concern:	Front of dwelling
Gutter concerns present	1

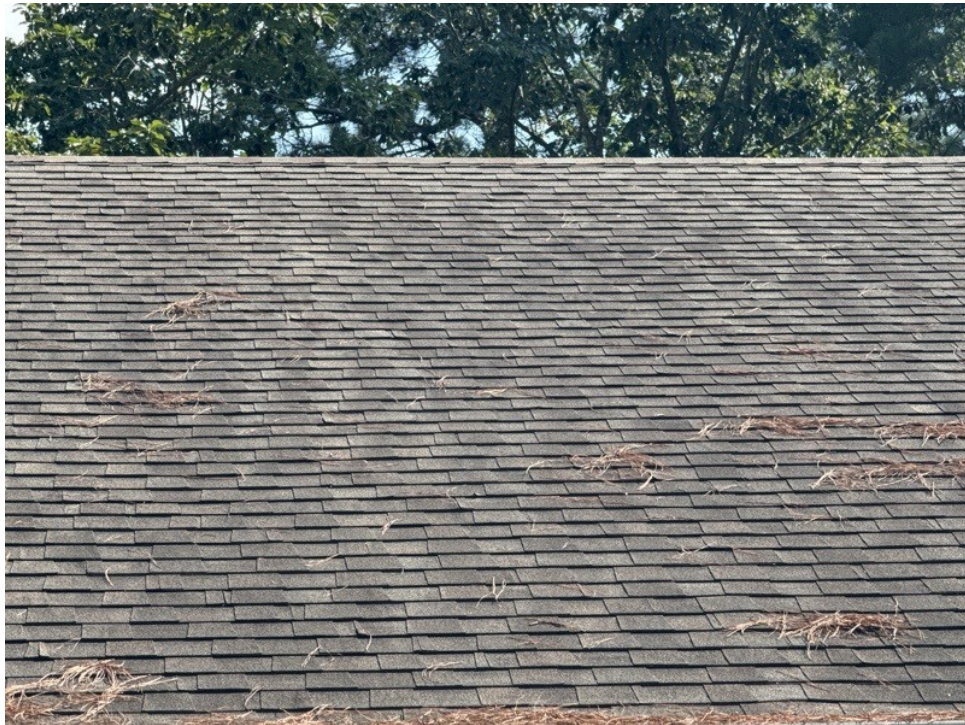
Roof verification, Left, Dwelling, Roof, Front, Sagging/Bowed

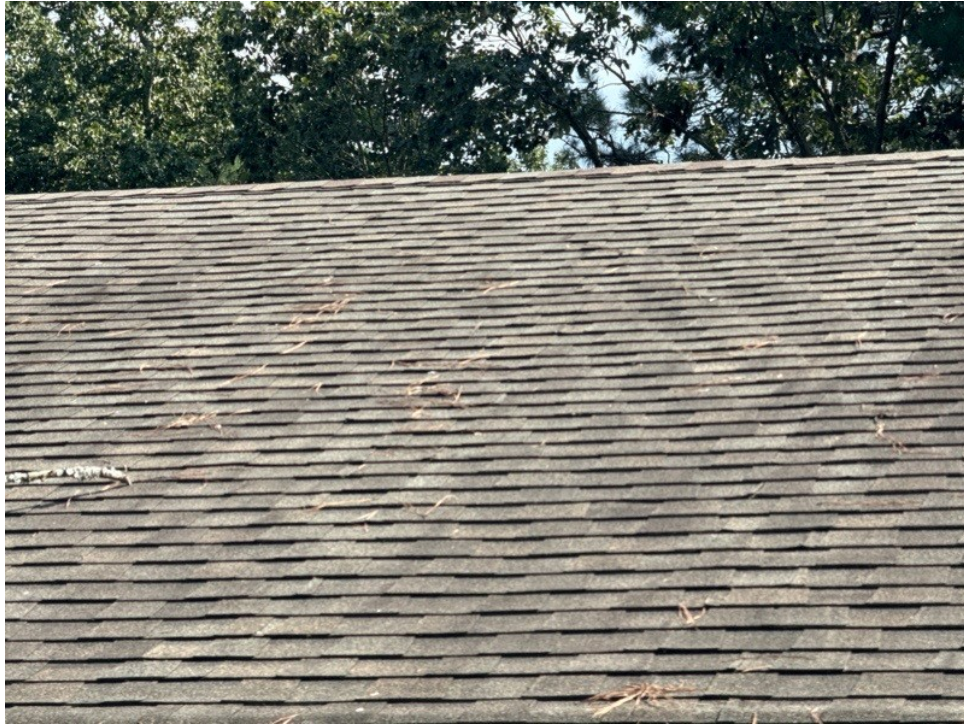
Roof verification, Rear, Right, Roof

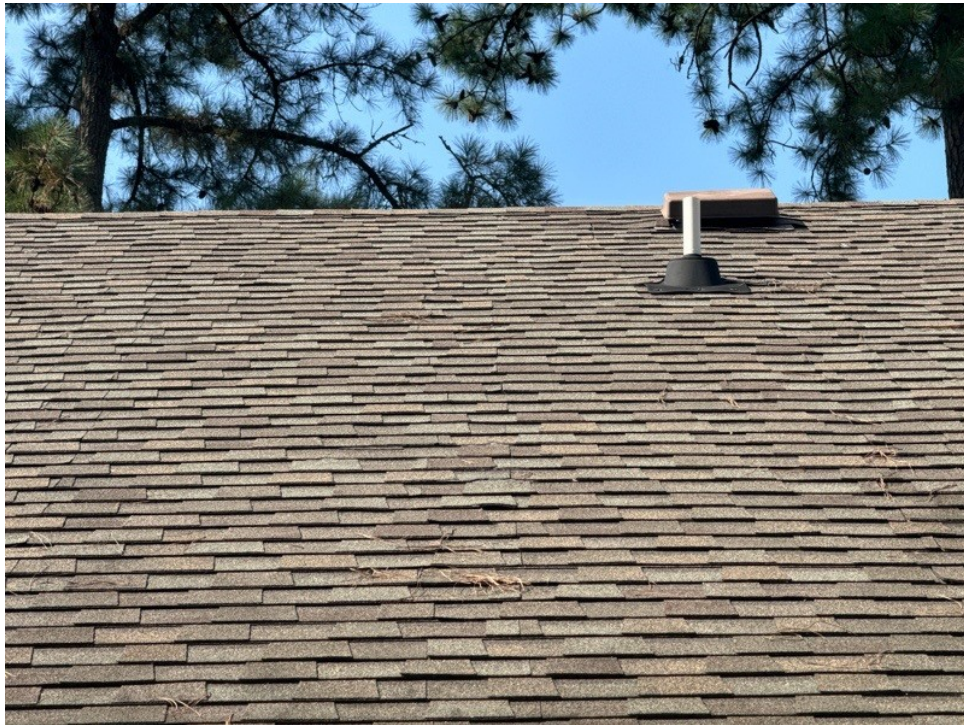
Roof verification, Rear, Left, Roof

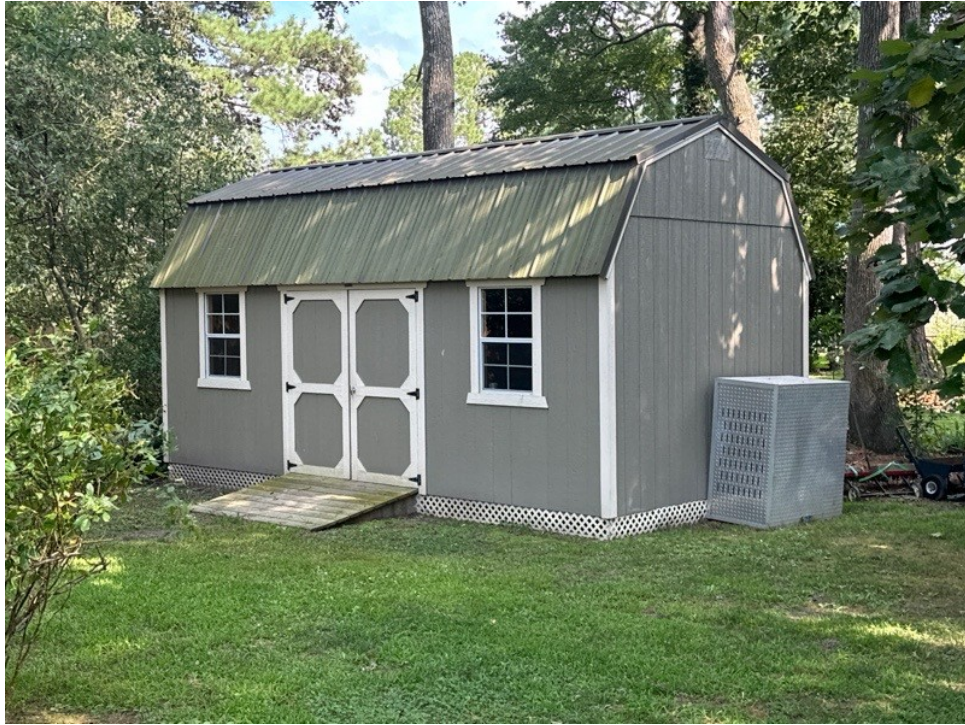
Outbuilding, Shed
