SageSure Insurance Managers,  
LLC\_Residential

Hagmon Simmons  
1606 TUCUMCARI DR  
HOUSTON, TX 77090

TRIUM Exterior w/RCE

**Case Number:** I-02645241

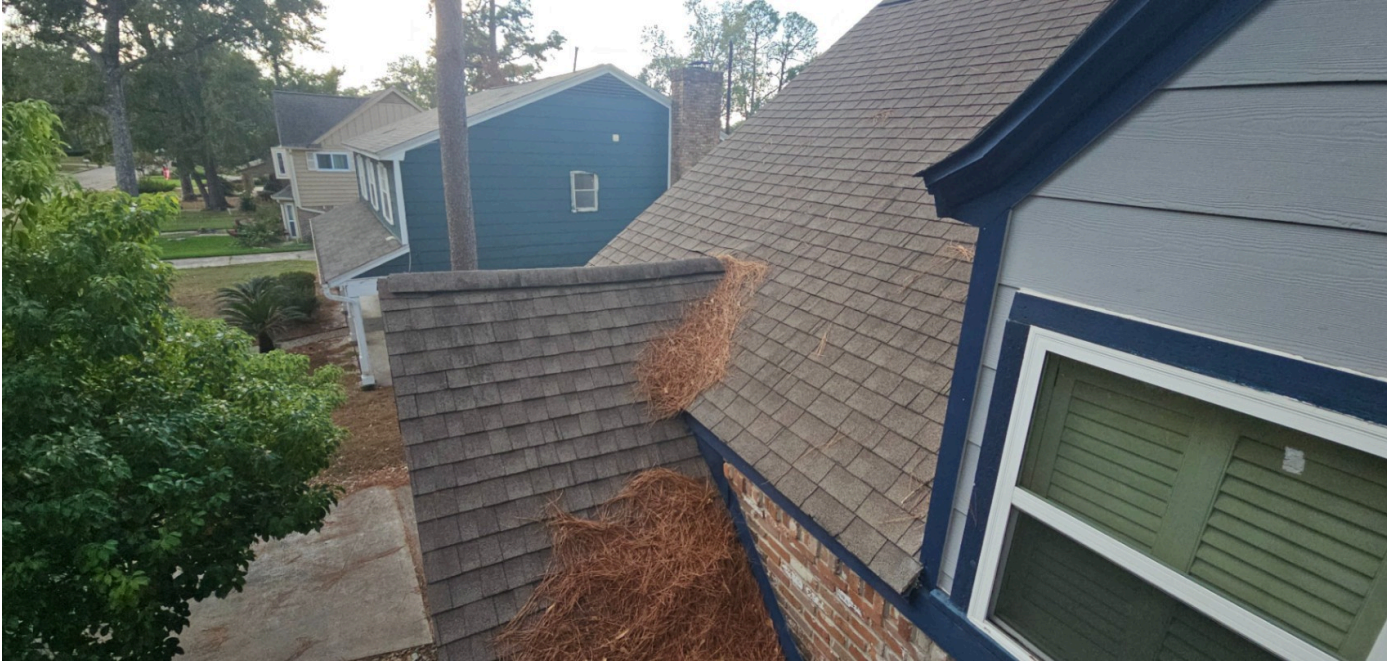
**Roof - Front**

<b>Description of "Other" Roof Condition:</b>	Pine needles on roof.	
<b>Adverse Roof Condition(s) Location:</b>	Front Roof, Right Roof, Left Roof, Rear Roof	
<b>General Roof Comments:</b>	Granular loss on roof.	
<b>Estimated Roof Age:</b>	0 - 5	
<b>Roof Covering:</b>	Rated Shingles (Architectural)	
<b>Roof Geometry (CHECK ALL ROOF SHAPES THAT ARE PRESENT ON THE DWELLING):</b>	Gable, Hip	
<b>% Gable Roof:</b>	75 %	
<b>% Hip Roof:</b>	25 %	
<b>Solar or Photovoltaic Panels Present?:</b>	No	
<b>Skylights:</b>	No	
<b>Adverse Chimney Condition(s):</b>	None Observed

100 AMP Service:	None
Other Hazard(s):	None Observed
Second Floor Hazard(s):	None Observed
Liability / Exposure:	None Observed
General Condition Comments:	Limbs overhang front, right and rear roof.

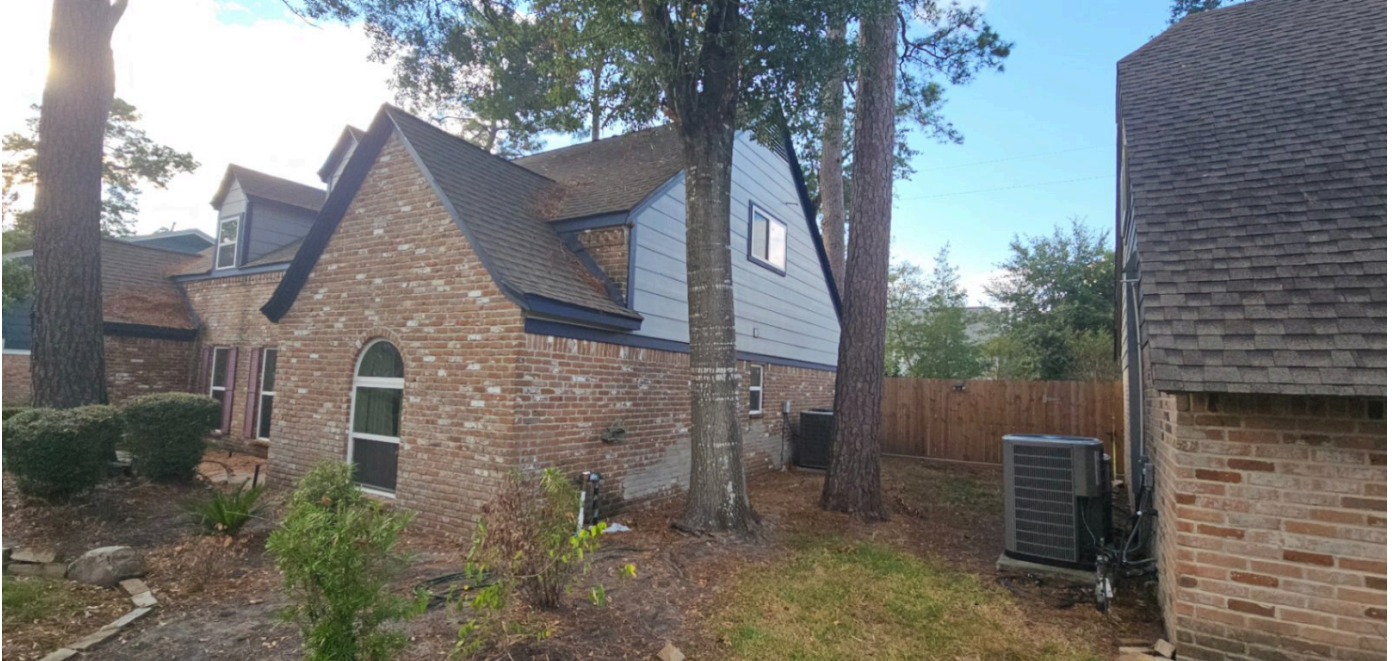
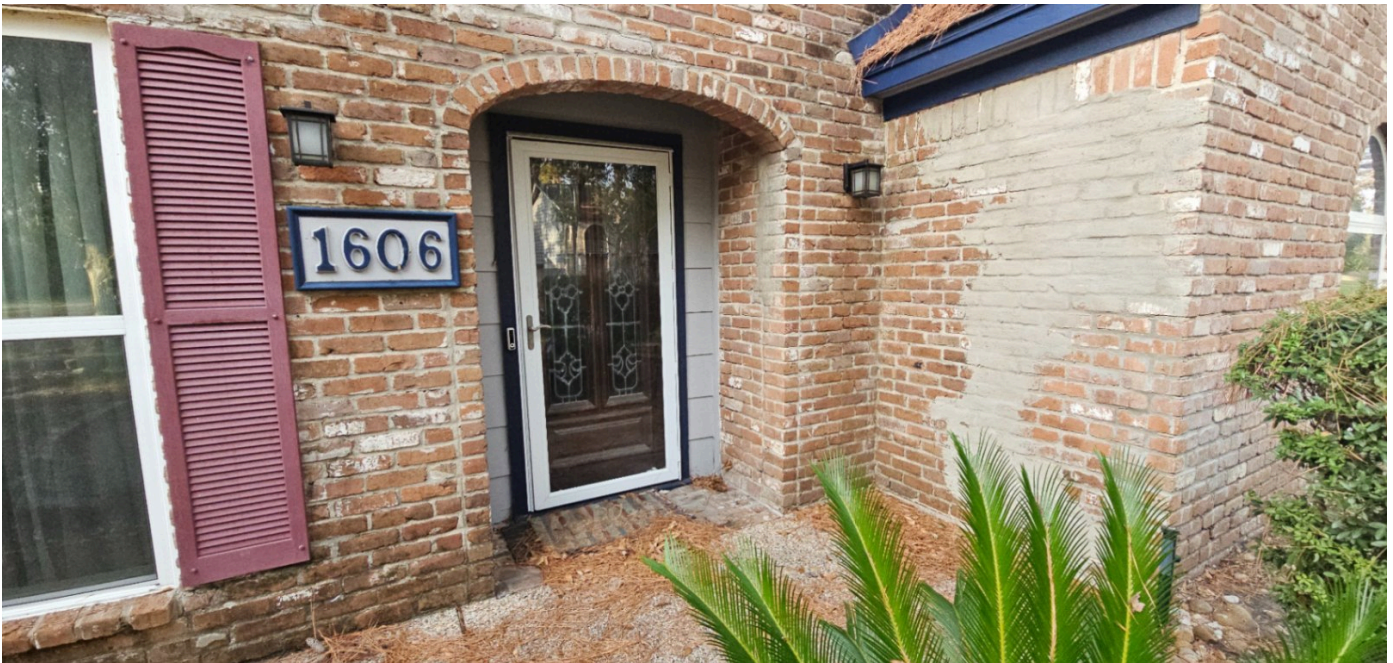
**Exterior Wall Hazard - Other**

Siding (Non-Masonry)	None Observed
Brick / Stone Walls (Masonry):	Other  
Brick / Stone Walls (Masonry) Hazard:	Brick was repaired on the front and right side
Exterior Wall Hazard Location:	Front, Right Side
Soffit/Fascia/Eave Hazard(s):	None Observed
Door Hazard(s):	None Observed
Window Hazard(s):	None Observed
Foundation Hazard(s):	None Observed
Porch / Patios / Decks Hazard(s):	None Observed
Steps Hazard(s):	None Observed
Gutter/Downspout Hazard(s):	None Observed
Sidewalk/Driveway Hazard(s):	None Observed
Yard/Premises Hazard(s):	None Observed
Tree Hazard(s):	Substantial branches (healthy or not) 3" or more in diameter that overhang roof by 6 feet or more  
Detached Garage Hazard(s):	None Observed
Outbuilding Hazard(s):	None Observed
Adjacent Exposures:	None Observed
Trampoline / Ramp Hazard(s):	None Observed
Fuel Storage Tank:	None Observed
Dog / Horse / Livestock Hazard(s):	None Observed
Business / Farming:	None Observed
