Inspection Report for Barb Pabst

Property Address: 4245 Jefferson St NE, Minneapolis, MN 55421

Comfort Home Inspections, Inc.

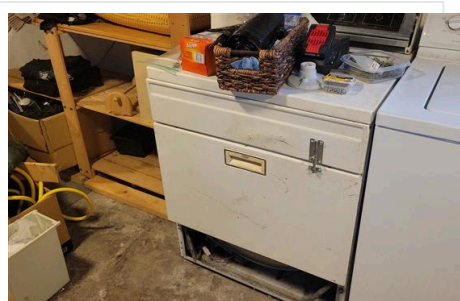
2.3

Dryer did not respond to controls.

Have a qualified appliance repair professional evaluated and repair unit as necessary.

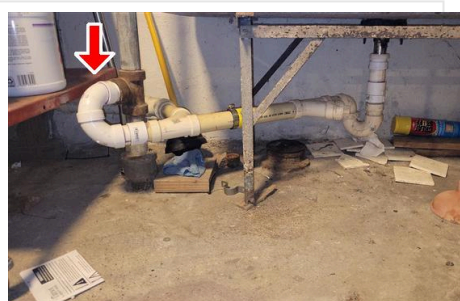
3.4
Under laundry tub

(1) Improper drain arrangement observed.

Have a qualified, licensed plumbing contractor evaluate and repair or replace as necessary.

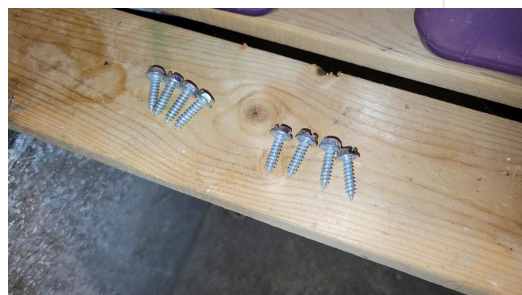
6.1

(2) One or more panel cover screws are pointed. Pointed screws are not appropriate for electrical enclosures. Replace any pointed screws with blunt end screws to avoid the possibility of puncturing a conductor.

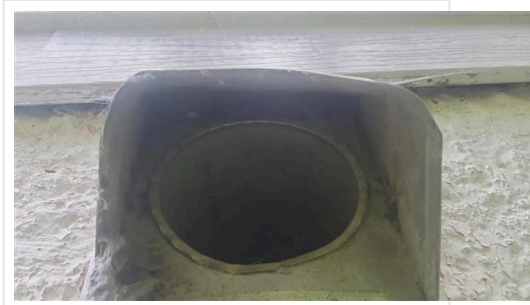
8.3

Vent termination damper is missing or not properly closing. Consider replacing unit with an appropriate vent termination.

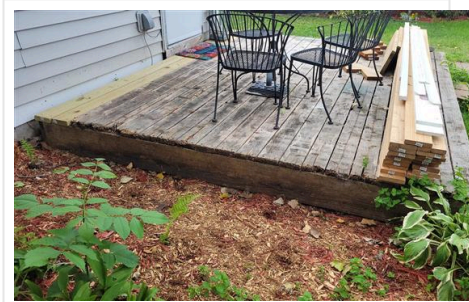
8.6

The deck exhibits a number of deficiencies including deteriorated and rotting wood. Have a qualified, licensed professional evaluate and repair as needed.

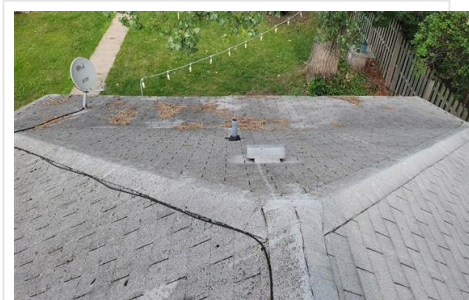
9.0

Roof covering is nearing the end of its useful life. Consider having a qualified, licensed roofing contractor evaluate and provide repair or replacement cost estimates prior to closing if possible.

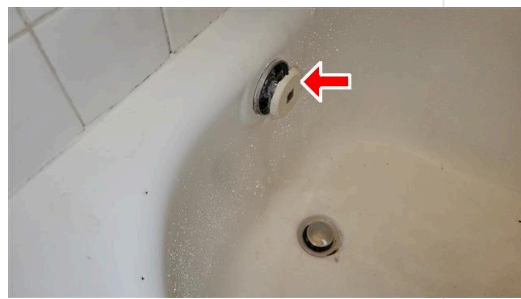
3.3

(1) Overflow at tub missing trim.

Have a qualified, licensed plumbing contractor evaluate and repair or replace as necessary.

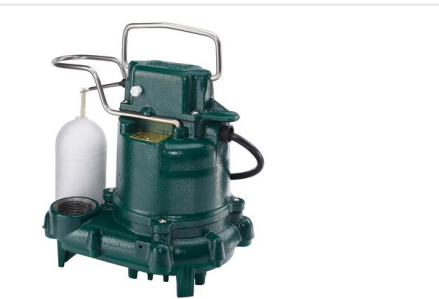
3.6
Correct Example

(2) Sump pump float observed to be a tethered cord type. This type can be less reliable in some situations. Consider upgrading entire pump to a unit with an integrated vertical type float for more reliability.

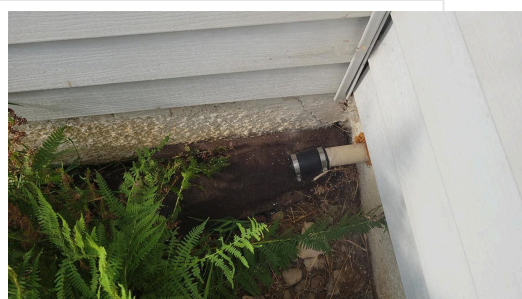
3.6

(3) Sump pump discharges near foundation. Installation of an extension is recommended to help avoid water re-entering foundation area.

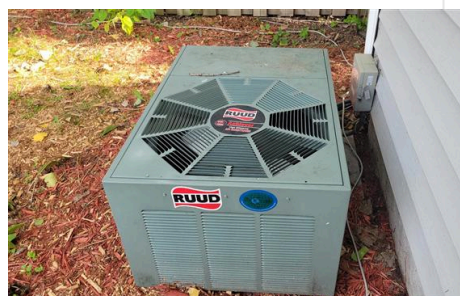
5.1

According to the serial number on the unit, the manufacture date is: 2002

The age of the unit is beyond its standard expected service life. For best performance and efficiency, consider budgeting to replace the unit in the near future.

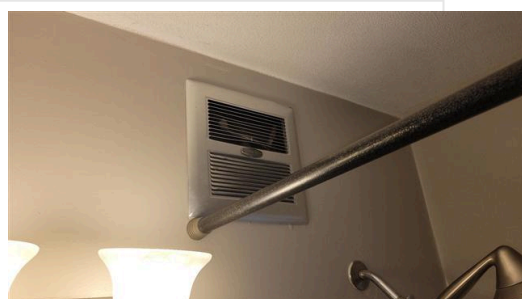
5.3

Exhaust fan operates with excessive noise. Have a qualified person evaluate the unit and repair or replace as necessary.

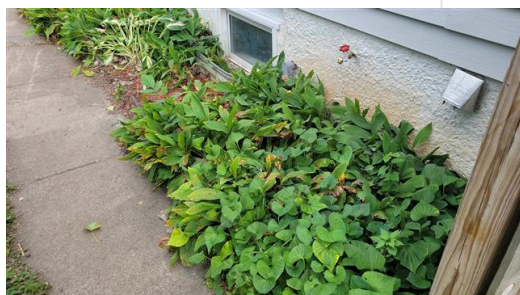
8.0

One or more areas observed having vegetation/ tree limbs/ shrubbery in contact with structure. All vegetation should be trimmed back from structure to avoid possible damage and to eliminate a potential path to the structure for moisture and pests.

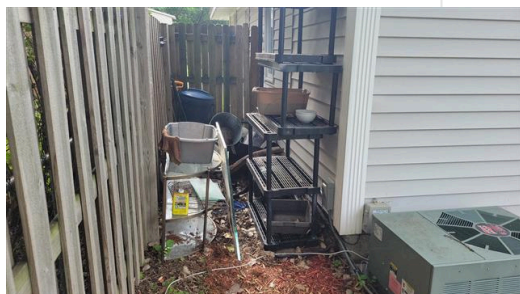
8.2

Debris observed against house/ wall cladding. This can hold moisture, attract pests, and damage wall cladding components. Removal is recommended.

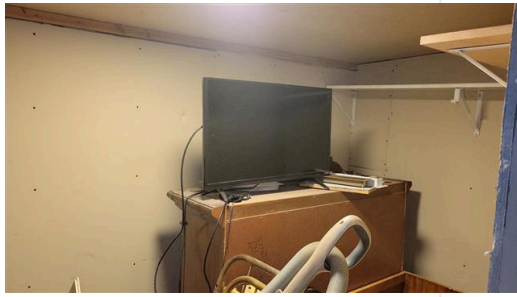
11.2

Repairs in progress observed. Consider verifying reason for repairs and the current status with seller if possible.

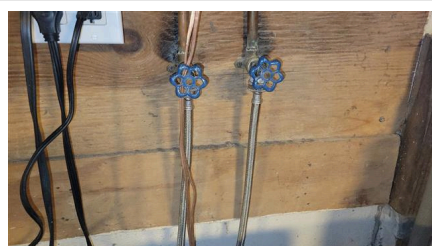
2.0

Washer connections observed to be intact. No leaks observed at the time of inspection.

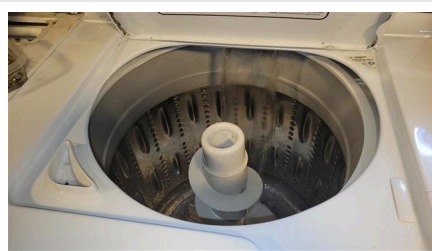
2.2

Washing machine was operated and was observed to be in good condition at the time of the inspection.

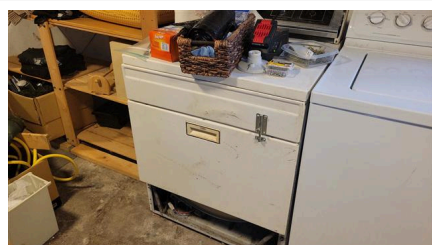
2.3

Dryer did not respond to controls.

Have a qualified appliance repair professional evaluated and repair unit as necessary.

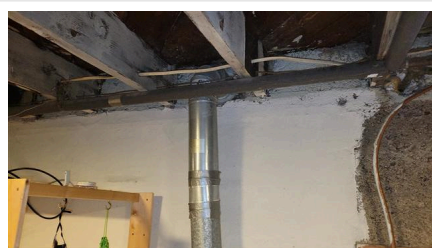
2.4

The dryer vent is serviceable. Unless the vent is visually accessible within the basement, crawl spaces or attic, and can be seen by the inspector, it can not be verified that this ventilation exhaust system vents to the exterior of the structure.

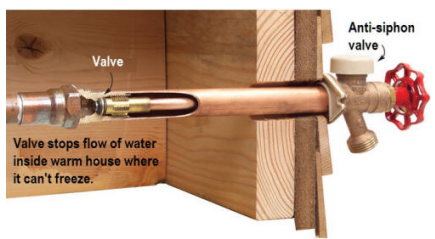
3.1 Frost-Proof example

Exterior hose connection valve does not appear to be frost-free type. This type of fixture should be shut off and drained prior to cold weather to avoid freeze damage.

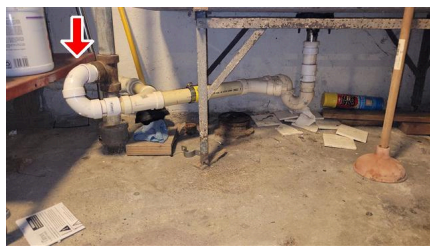
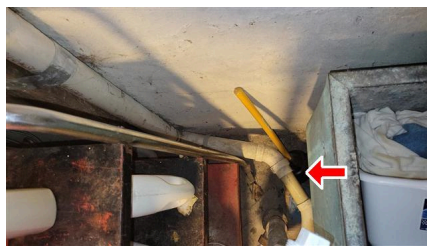
3.4
Under laundry tub

(1) Improper drain arrangement observed.

Have a qualified, licensed plumbing contractor evaluate and repair or replace as necessary.

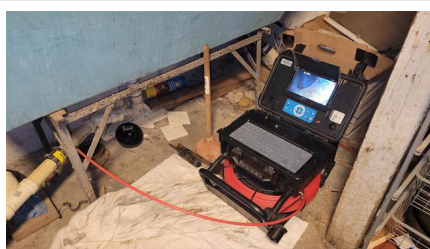
3.4

(2) A video sewer line inspection was performed. No defects were observed at the time of the inspection.

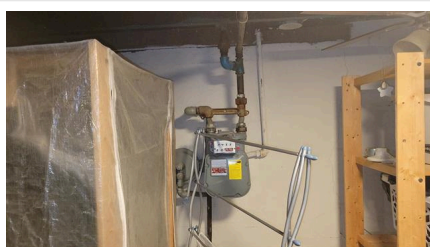
3.5

Gas meter was observed at property. No obvious leaks or indications of defects noted at the time of the inspection.

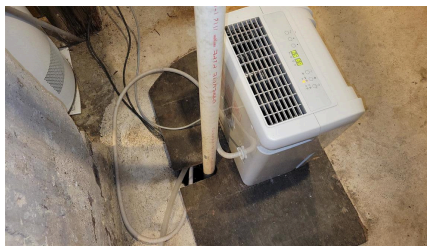
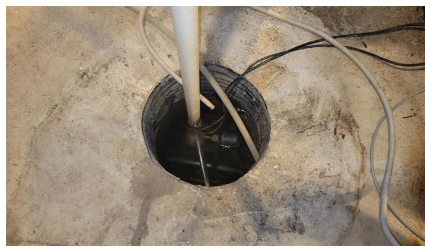
3.6

(1) Sump pump was tested and is verified operational at the time of inspection. Perform regular tests on pump to verify its operability, replace unit every three to four years under normal use, and more frequently under heavy use to avoid pump failure and related damage.

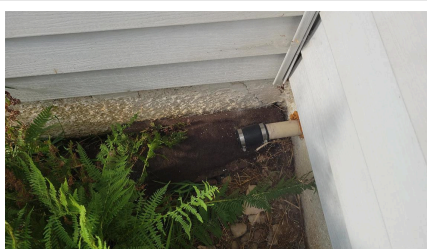
3.6

(3) Sump pump discharges near foundation. Installation of an extension is recommended to help avoid water re-entering foundation area.

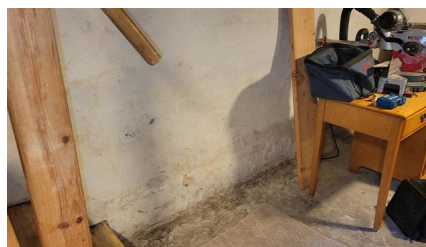
4.0

(1) Basement/ foundation observed to be in good condition at the time of inspection with no visible signs of structural issues.

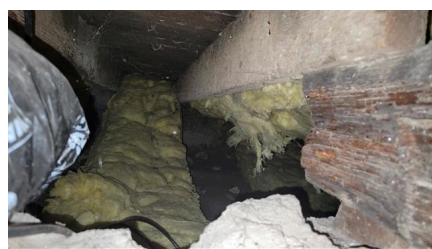
4.0

(2) Crawlspace observed. Limited inspection provided from entry point. No defects were observed.

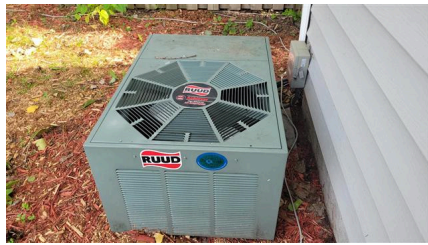
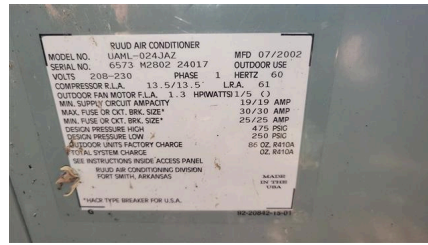
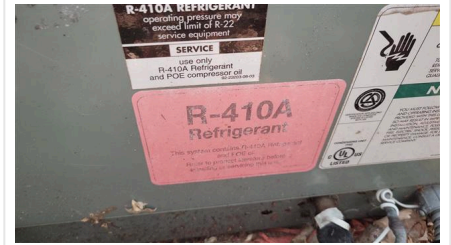
5.1

According to the serial number on the unit, manufacture date is: 2002

The age of the unit is beyond its standard expected service life. For best performance and efficiency, consider budgeting to replace unit in the near future.

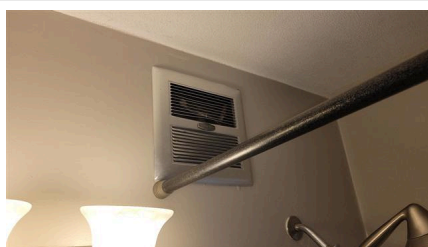
5.3

Exhaust fan operates with excessive noise. Have a qualified person evaluate the unit and repair or replace as necessary.

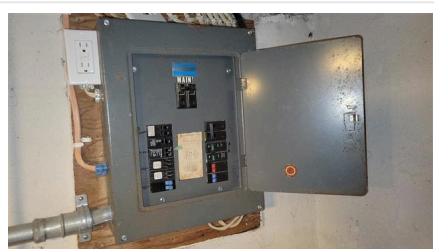
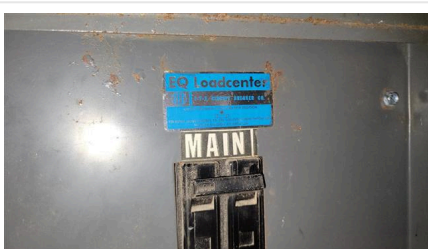
6.1

(1) Other than any listed in this report, no defects were observed at the electrical panel at the time of inspection.

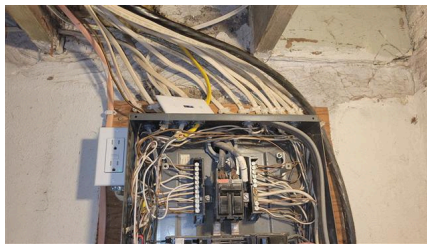
6.2

No defects were observed. Solid copper wire observed on 15 and 20 amp circuits. Stranded aluminum is commonly used on higher amperage circuits. All circuits visible within the main panel appear to have the appropriate size wire for the respective breaker.

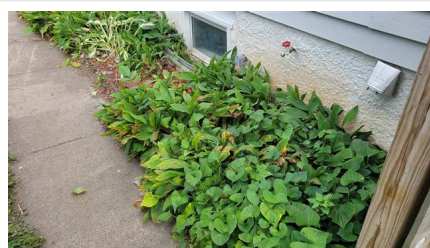
8.0

One or more areas observed having vegetation/ tree limbs/ shrubbery in contact with structure. All vegetation should be trimmed back from structure to avoid possible damage and to eliminate a potential path to the structure for moisture and pests.

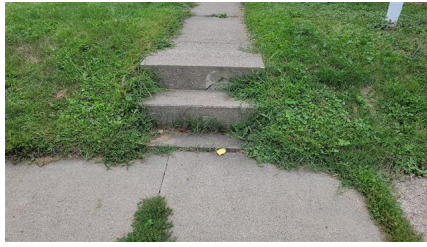
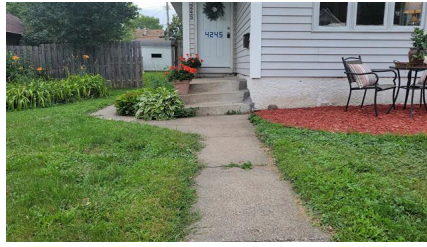
8.1

(1) Settling observed at steps and walkway.

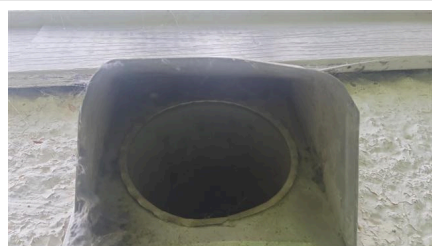
8.3

Vent termination damper is missing or not properly closing. Consider replacing unit with an appropriate vent termination.

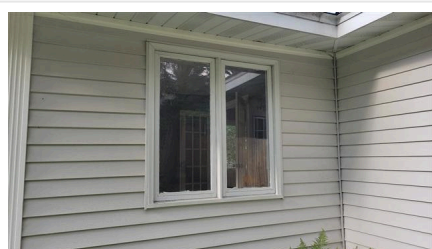
8.5

The exterior side of the windows are in acceptable condition at the time of inspection.

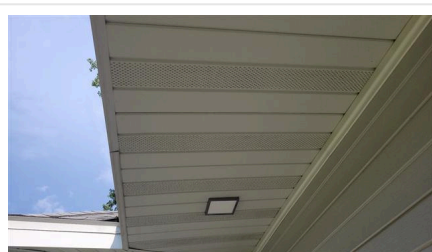
8.7

The eaves, soffits and fascia areas observed to be in good condition at the time of inspection.

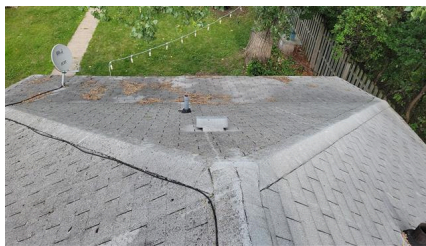
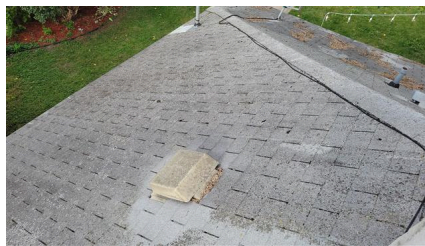
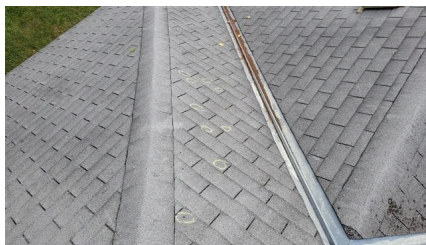
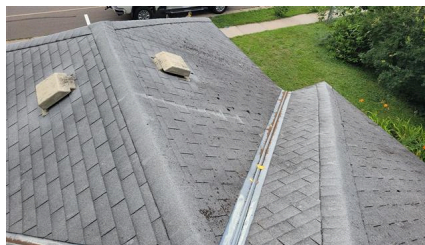
9.0

Roof covering is nearing the end of its useful life. Consider having a qualified, licensed roofing contractor evaluate and provide repair or replacement cost estimates prior to closing if possible.

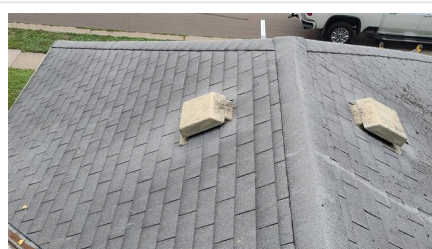
9.1

Visible roof penetrations and flashing observed to be in acceptable condition at the time of the inspection.

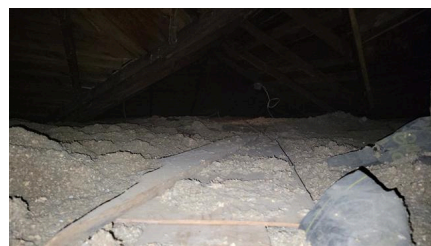
10.1

Attic insulation depth and coverage is acceptable. As a general rule, most homes can benefit from additional insulation.

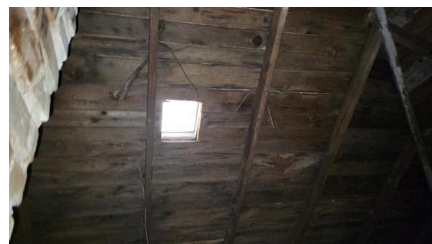
10.2

Attic ventilation observed to be adequate at the time of the inspection. As a general rule, most attics can benefit from increased ventilation.

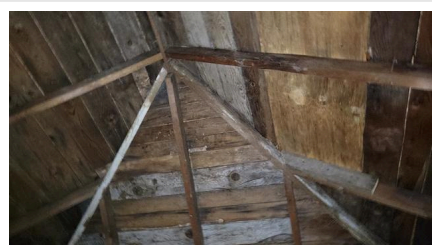
10.4

Attic side of roof sheathing observed to be in good condition and free of any evidence of water stains or leaking.

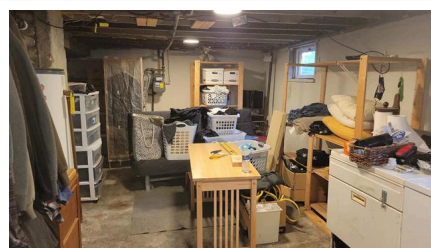
11.0

One or more windows were blocked by personal property or furniture and were not accessible for evaluation.

Consider carefully examining any of these areas after property has been removed if possible.

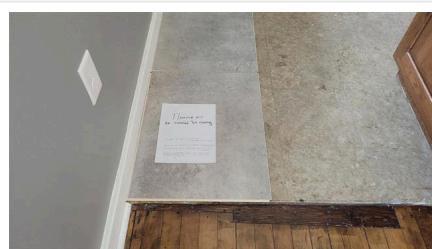
11.3

Repairs in progress observed. Consider verifying reason for repairs and the current status with seller if possible.

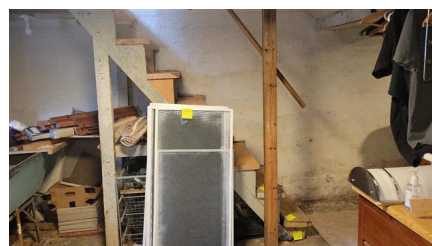
11.4

Loose stair treads observed, repairs are recommended.

Fall hazard observed at stairway. A proper guard should be installed with vertical balusters spaced less than 4" apart.

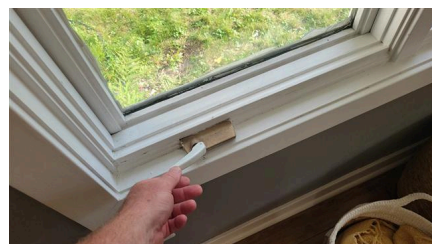
11.7

(2) Window operator hardware is not functioning properly. Have a qualified person evaluate and repair as necessary for best performance.

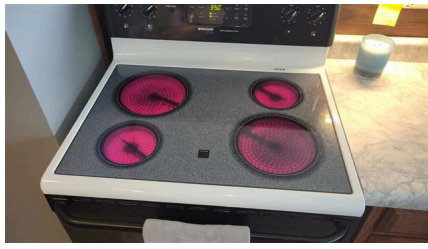
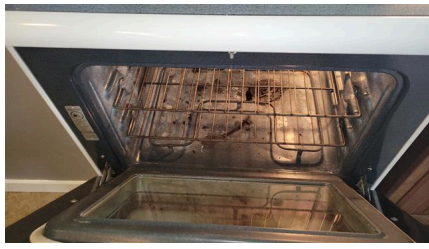
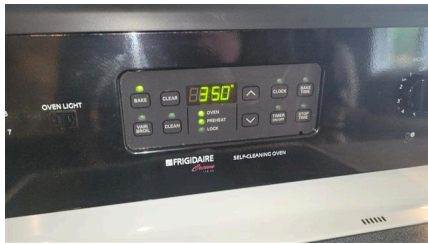
12.1

(1) Burners and oven were operated. No defects were observed at the time of the inspection.
