Property Inspection Report

Property inspection completed by CIS Group powered by Navigator

Insured:	ADRIENNE MEIER	Survey Address:	317 NICOLLET AVE
Survey ID:	31641534	Survey City:	NORTH MANKATO
Policy Number:	335119015	Survey State:	MN
Agent Name:	ANDREW SCHMITZ	Survey Zip:	56003
Agent Number:	13803AH		
Agent Phone:	6514568834	Primary Phone:	5078223770
Agent Email:	aschmitz@farmersagent.com		
Replacement Cost Code:	HV	Valuation ID:	A4Y6-NV65
Reclassified PPC:		Policy Inception Date:	05/08/2021
ADHOCProjDesc:		Inspection Type Out:	Exterior
Transaction Type:	New Business on New Household		
Fireline Score:

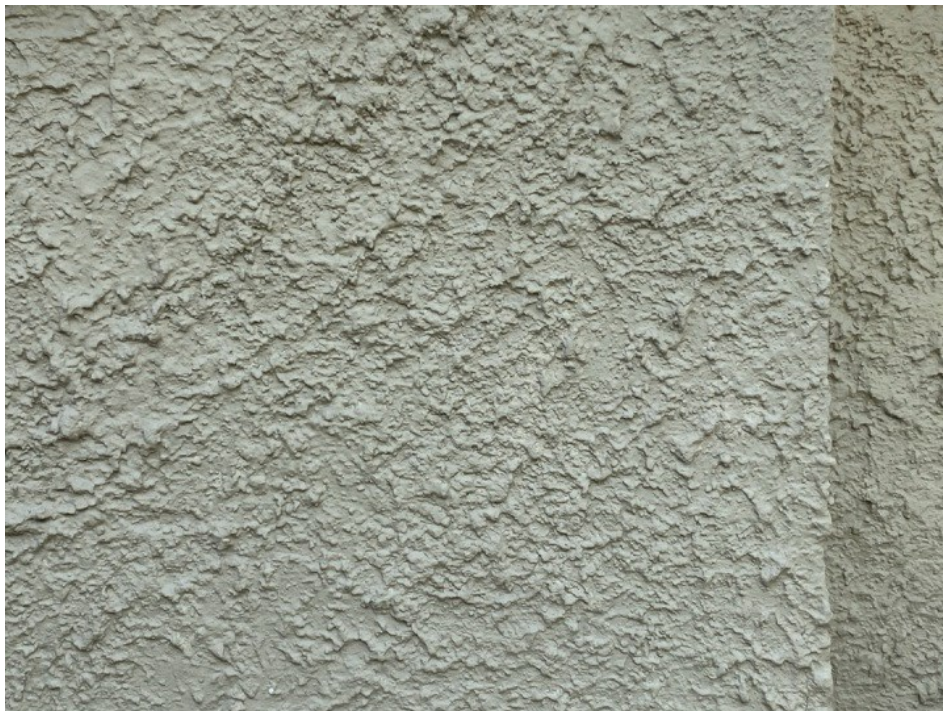
8 Exterior Wall Closeup

- Exterior Wall Hazard
 - Dry Rot: Dry rot observed on siding.
 - Paint Peeling / Unpainted: Paint showing extreme wear.
 - Other (See Comments): Patches evident.
- Porch / Patio / Deck / Stairs Hazard
 - Missing Railing: Missing railing on porch over 3ft.
