SageSure Insurance Managers,  
LLC\_Residential

Hagmon Simmons  
1606 TUCUMCARI DR  
HOUSTON, TX 77090

TRIUM Exterior w/RCE

**Case Number:** I-02645241

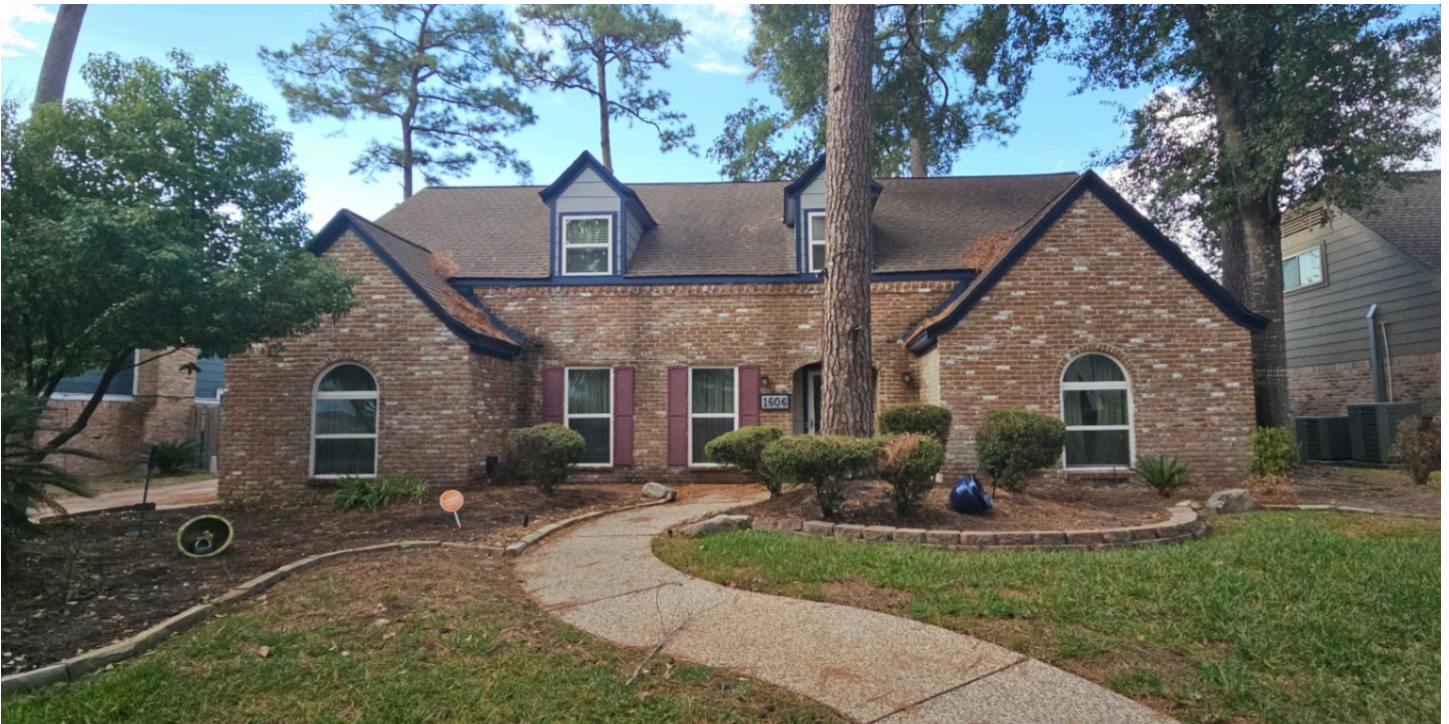
Exterior - Front

Adverse Conditions	Total Score: 30 pts
ROOF - MAJOR: Other	10 pts
BRICK /STONE WALLS (Masonry) – MAJOR: Other	10 pts
TREES - MAJOR: Branches 3" more in diameter; overhang roof by 6ft/more	10 pts

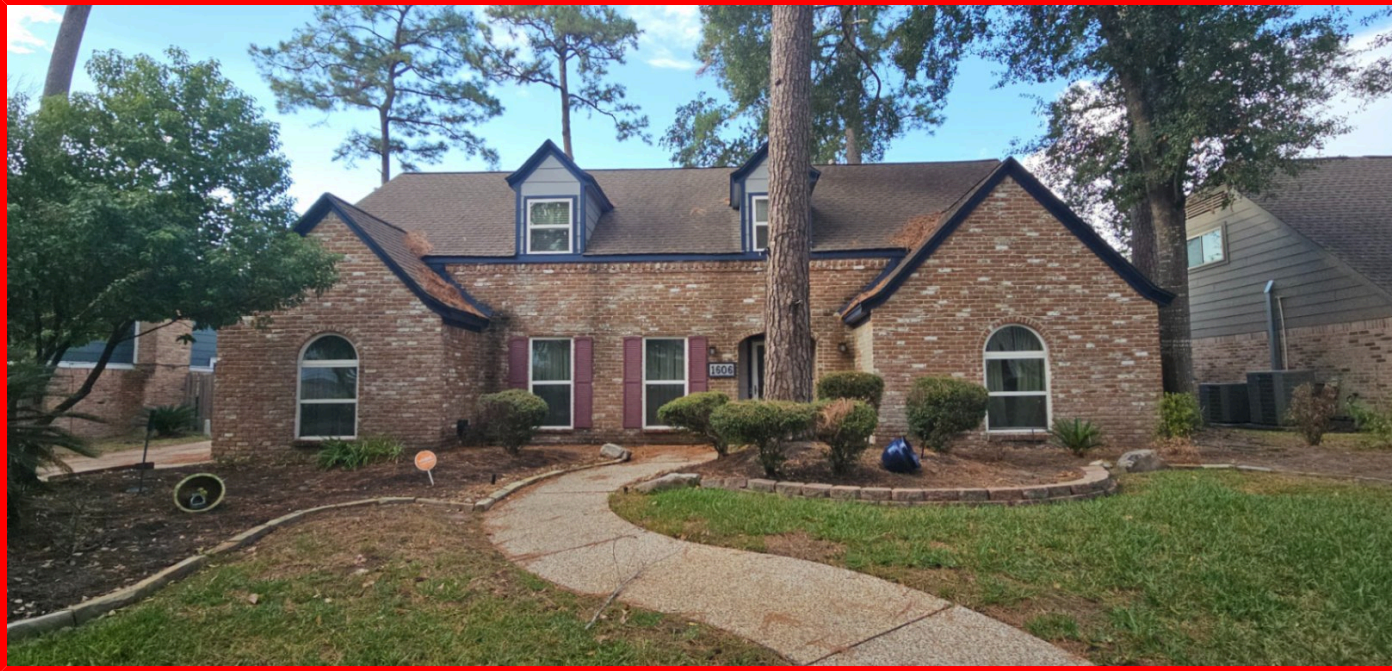
Exterior - Front

Siding (Non-Masonry)	None Observed
Brick / Stone Walls (Masonry):	Other  
Brick / Stone Walls (Masonry) Hazard:	Brick was repaired on the front and right side
Exterior Wall Hazard Location:	Front, Right Side
Soffit/Fascia/Eave Hazard(s):	None Observed
Door Hazard(s):	None Observed
Window Hazard(s):	None Observed
Foundation Hazard(s):	None Observed
Porch / Patios / Decks Hazard(s):	None Observed
Steps Hazard(s):	None Observed
Gutter/Downspout Hazard(s):	None Observed
Sidewalk/Driveway Hazard(s):	None Observed
Yard/Premises Hazard(s):	None Observed
Tree Hazard(s):	Substantial branches (healthy or not) 3" or more in diameter that overhang roof by 6 feet or more  
Detached Garage Hazard(s):	None Observed
Outbuilding Hazard(s):	None Observed
Adjacent Exposures:	None Observed
Trampoline / Ramp Hazard(s):	None Observed
Fuel Storage Tank:	None Observed
Dog / Horse / Livestock Hazard(s):	None Observed
Business / Farming:	None Observed

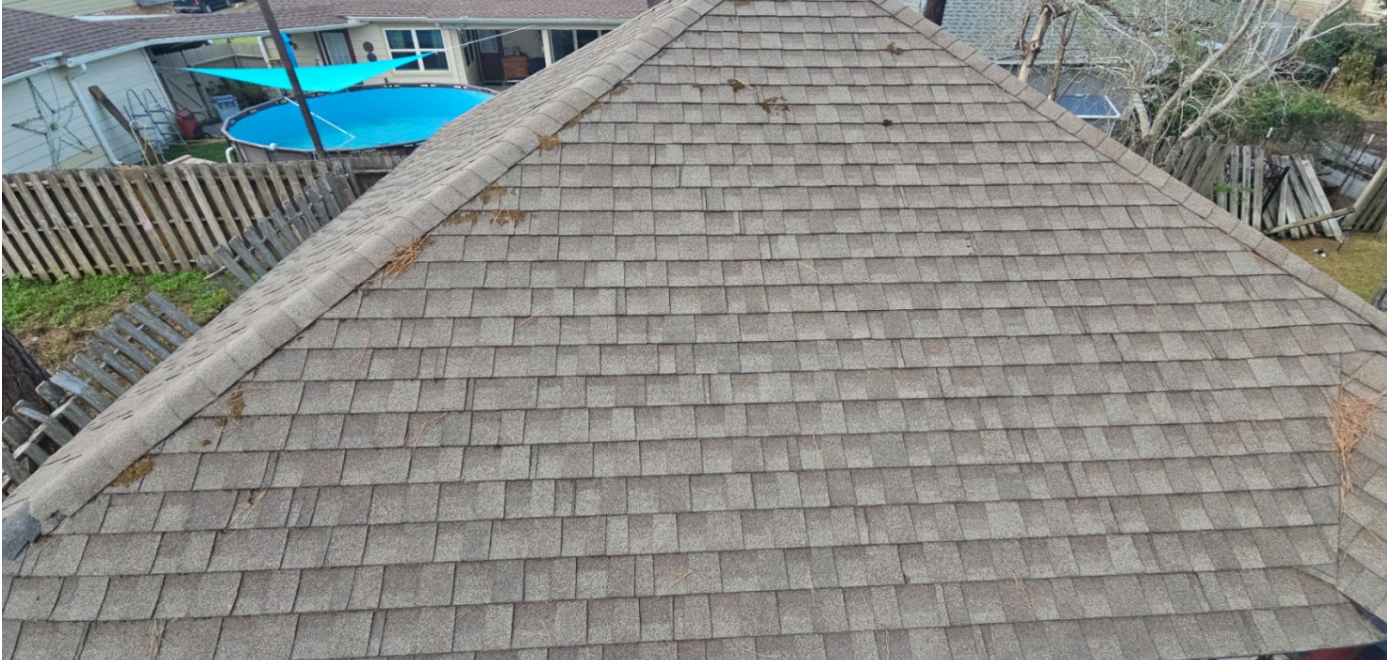
**Roof - Garage**

<b>Description of "Other" Roof Condition:</b>	Pine needles on roof.	
<b>Adverse Roof Condition(s) Location:</b>	Front Roof, Right Roof, Left Roof, Rear Roof	
<b>General Roof Comments:</b>	Granular loss on roof.	
<b>Estimated Roof Age:</b>	0 - 5	
<b>Roof Covering:</b>	Rated Shingles (Architectural)	
<b>Roof Geometry (CHECK ALL ROOF SHAPES THAT ARE PRESENT ON THE DWELLING):</b>	Gable, Hip	
<b>% Gable Roof:</b>	75 %	
<b>% Hip Roof:</b>	25 %	
<b>Solar or Photovoltaic Panels Present?:</b>	No	
<b>Skylights:</b>	No	
<b>Adverse Chimney Condition(s):</b>	None Observed
